Access Compliance Report

Public Rights-of-Way

(Curb Ramps)

Intersection ID: 27432	Main Street: BALLANTYNE COMMONS PY	Cross Street: DURANT BV	Location: NW
ADA ID: A7359C14412B	Ramp Type: Perp	Initial Pass/Fail: Fail	Overall Compliance: No
Codes/Mitigation Info/Possible Solution		Field Measurements/Component Compliance	
Severity Score: 13.75

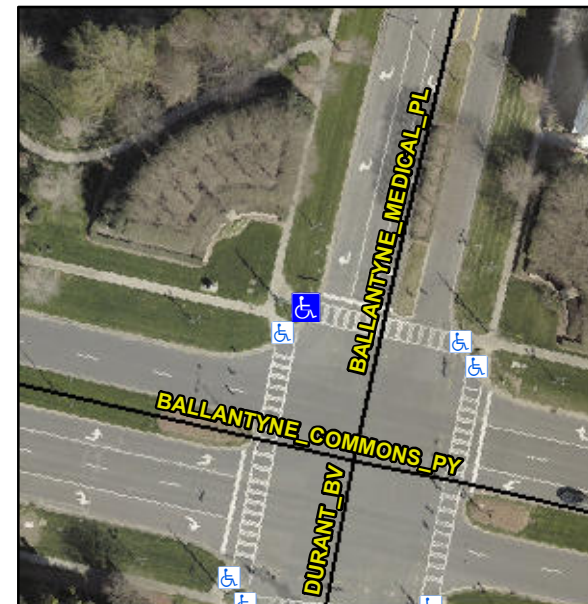
Not Found, R304.2.2, R304.5.3

Compliance	Description	Data	Compliance	Description	Data
N/A	Ramp Length (in)	86.0	No	Ramp Slope (%)	8.4
Yes	Ramp Width (in)	48.0	No	Ramp XSlope (%)	3.3
N/A	Flare Type LT	N/A	N/A	Flare Type RT	N/A
N/A	Flare Slope LT (%)	N/A	N/A	Flare Slope RT (%)	N/A
N/A	Flare Traversable LT?	N/A	N/A	Flare Traversable RT?	N/A
N/A	Landing Length (in)	N/A	N/A	DWS Provided?	N/A
N/A	Landing Width (in)	N/A	N/A	DWS Contrast?	N/A
N/A	Landing Slope (%)	N/A	N/A	DWS Length (in)	N/A
N/A	Landing X Slope (%)	N/A	N/A	DWS Full Width?	N/A
N/A	Landing Curb? (Y/N)	N/A	N/A	DWS Offset (in)	N/A
N/A	Shared Landing?	N/A			
N/A	Gutter Ponding?	N/A	N/A	Gutter Slope (%)	N/A
N/A	Gutter Lip Ht (in)	N/A	N/A	Gutter X Slope (%)	N/A
N/A	Painted X Walk1?	Yes	N/A	Painted X Walk2?	N/A
	X Walk 1 Direction	To SE		X Walk 2 Direction	N/A
N/A	X Walk 1 Width (in)	124.5	N/A	X Walk 2 Width (in)	N/A
	X Walk 1 Slope (%)	0.8		X Walk 2 Slope (%)	N/A
	X Walk 1 X Slope (%)	1.5		X Walk 2 X Slope (%)	N/A

N/A	Ramp inside XWalk1?	Yes	N/A	Ramp inside XWalk2?	N/A
	Road Slope (%)	N/A	N/A	Clear Space?	N/A
	Road X Slope (%)	N/A	N/A	Clear Space to XWalk (in)	N/A
N/A	Any Obstructions?	N/A	N/A	Storm Grate/Utility Hazard?	N/A
	Obstruction Type			Storm Grate/Utility Type	
		N/A			N/A
		Yes		Surface Condition? (G/P)	Good

Possible Solutions:

Remove & Replace Entire Ramp.

Total Cost: \$ 1850.00
