Access Compliance Report

Public Rights-of-Way

(Curb Ramps)

Intersection ID: 5879	Main Street: NEVIN_RD	Cross Street: ZION_RENAISSANCE_LN	Location: NW
ADA ID: A73A30ED1273	Ramp Type: MedianPerp	Initial Pass/Fail: Fail	Overall Compliance: No
		Severity Score: 12.5

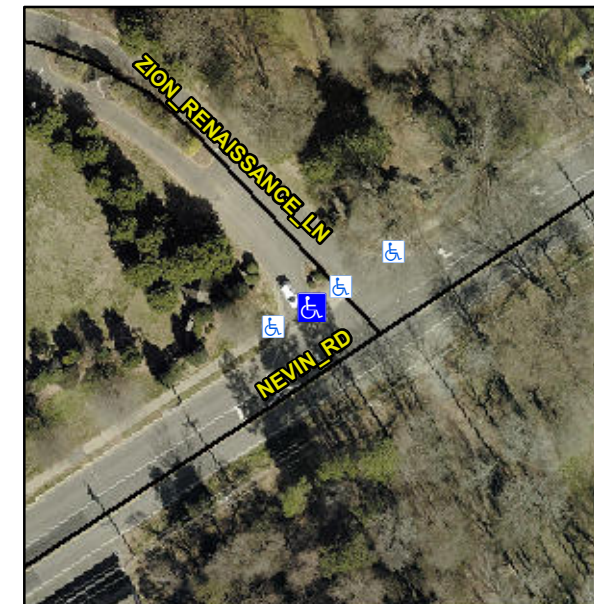
Not Found, R304.2.2

Compliance	Description	Data	Compliance	Description	Data
N/A	Ramp Length (in)	48.0	No	Ramp Slope (%)	11.4
Yes	Ramp Width (in)	68.0	Yes	Ramp XSlope (%)	1.5
N/A	Flare Type LT	N/A	N/A	Flare Type RT	N/A
N/A	Flare Slope LT (%)	N/A	N/A	Flare Slope RT (%)	N/A
N/A	Flare Traversable LT?	N/A	N/A	Flare Traversable RT?	N/A
N/A	Landing Length (in)	N/A	N/A	DWS Provided?	N/A
N/A	Landing Width (in)	N/A	N/A	DWS Contrast?	N/A
N/A	Landing Slope (%)	N/A	N/A	DWS Length (in)	N/A
N/A	Landing X Slope (%)	N/A	N/A	DWS Full Width?	N/A
N/A	Landing Curb? (Y/N)	N/A	N/A	DWS Offset (in)	N/A
N/A	Shared Landing?	N/A			
N/A	Gutter Ponding?	N/A	N/A	Gutter Slope (%)	N/A
N/A	Gutter Lip Ht (in)	N/A	N/A	Gutter X Slope (%)	N/A
N/A	Painted X Walk1?	No	N/A	Painted X Walk2?	N/A
	X Walk 1 Direction	To SW		X Walk 2 Direction	N/A
N/A	X Walk 1 Width (in)	N/A	N/A	X Walk 2 Width (in)	N/A
	X Walk 1 Slope (%)	2.5		X Walk 2 Slope (%)	N/A
	X Walk 1 X Slope (%)	0.1		X Walk 2 X Slope (%)	N/A

Remove & Replace Entire Ramp.
