# Access Compliance Report

## Public Rights-of-Way

### (Curb Ramps)

Intersection ID: 43762	Main Street: HELENS_LN	Cross Street: ZIEGLER_LN	Location: NW
ADA ID: A75252B17438	Ramp Type: PerpDiag	Initial Pass/Fail: Fail	Overall Compliance: No
			Severity Score: 33.75

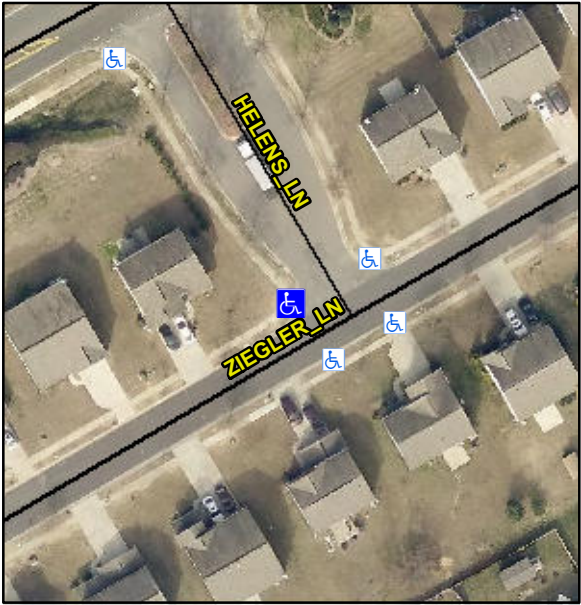
Possible Solutions:		<b>Compliance</b>	<b>Description</b>	<b>Data</b>
	<b>Remove &amp; Replace Curb Ramp With Two New Directional Ramps or Equivalent.</b>		<b>No</b>	Ramp Length (in)	48.0
			<b>No</b>	Ramp Width (in)	38.0
			<b>N/A</b>	Flare Type LT	N/A
			<b>N/A</b>	Flare Slope LT (%)	N/A
			<b>N/A</b>	Flare Traversable LT?	N/A
			<b>N/A</b>	Landing Length (in)	N/A
			<b>N/A</b>	Landing Width (in)	N/A
			<b>N/A</b>	Landing Slope (%)	N/A
			<b>N/A</b>	Landing X Slope (%)	N/A
<p>Surveyor Notes:</p> <p><b>N/A</b></p> <p>PROW/ADA:</p> <p><b>R304.5.1, R304.2.2, R304.5.3</b></p>			<b>N/A</b>	Flare Type RT	N/A
			<b>N/A</b>	Flare Slope RT (%)	N/A
			<b>N/A</b>	Flare Traversable RT?	N/A
			<b>N/A</b>	DWS Provided?	N/A
			<b>N/A</b>	DWS Contrast?	N/A
			<b>N/A</b>	DWS Length (in)	N/A
			<b>N/A</b>	DWS Full Width?	N/A
			<b>N/A</b>	DWS Offset (in)	N/A
