# Access Compliance Report

## Public Rights-of-Way

### (Curb Ramps)

| Intersection ID: 8132 | Main Street: OLD_CONCORD_RD | Cross Street: BRANCH_HILL_CR | Location: | N |

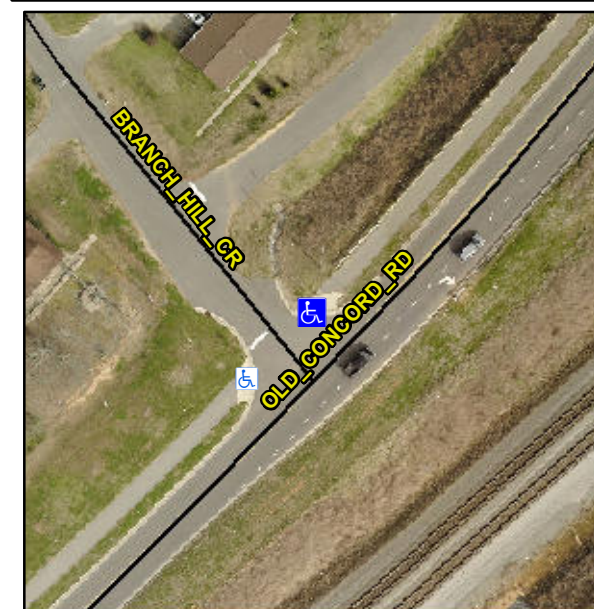
| ADA ID: A75B17897F1B | Ramp Type: Perp | Initial Pass/Fail: Fail | Overall Compliance: No | Severity Score: 25 |

**Not Found, R304.2.2, R304.5.3**

| Compliance | Description | Data | Compliance | Description | Data |
|---|---|---|---|---|---|
| N/A | Ramp Length (in) | 79.0 | No | Ramp Slope (%) | 8.8 |
| Yes | Ramp Width (in) | 77.0 | No | Ramp XSlope (%) | 6.3 |

**Remove & Replace Entire Ramp.**

Total Cost: \$ 1850.00
