# Access Compliance Report

## Public Rights-of-Way

### (Curb Ramps)

Intersection ID: 24531	Main Street: CARMEL_RD	Cross Street: WINDWOOD_CR	Location: NW
ADA ID: A76BD4488C49	Ramp Type: PerpDiag	Initial Pass/Fail: Fail	Overall Compliance: No
Severity Score: 22.5			
Codes/Mitigation Info/Possible Solution		Field Measurements/Component Compliance

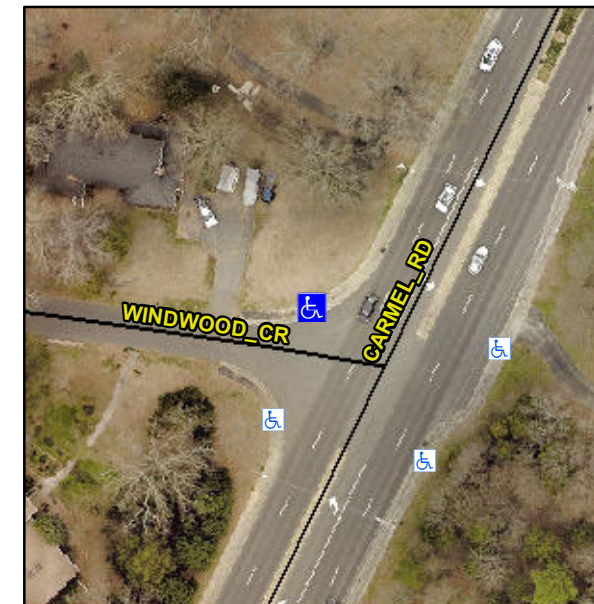
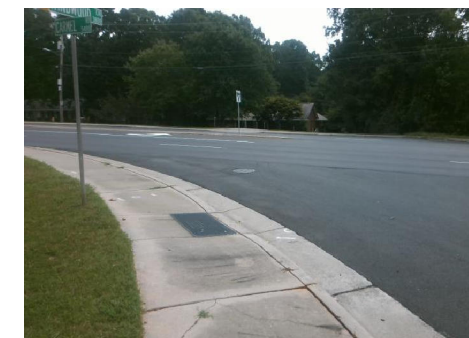
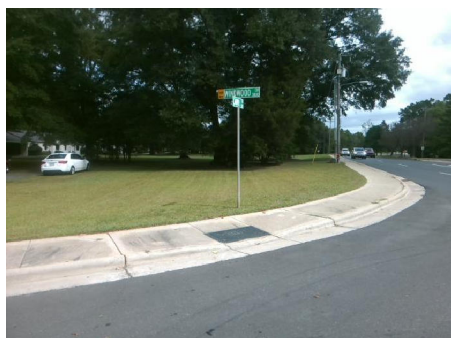
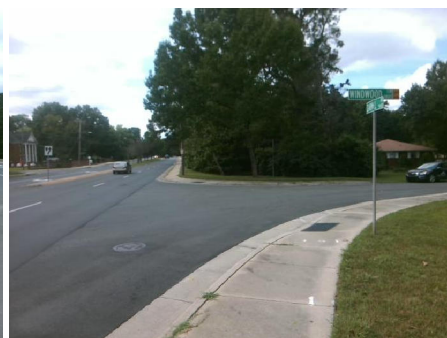
**Not Found, R304.5.1, R304.2.2, R304.5.3**

Compliance	Description	Data	Compliance	Description	Data
N/A	Ramp Length (in)	60.0	No	Ramp Slope (%)	10.2
No	Ramp Width (in)	44.0	No	Ramp XSlope (%)	2.9
N/A	Flare Type LT	N/A	N/A	Flare Type RT	N/A
N/A	Flare Slope LT (%)	N/A	N/A	Flare Slope RT (%)	N/A
N/A	Flare Traversable LT?	N/A	N/A	Flare Traversable RT?	N/A
N/A	Landing Length (in)	N/A	N/A	DWS Provided?	N/A
N/A	Landing Width (in)	N/A	N/A	DWS Contrast?	N/A
N/A	Landing Slope (%)	N/A	N/A	DWS Length (in)	N/A
N/A	Landing X Slope (%)	N/A	N/A	DWS Full Width?	N/A
N/A	Landing Curb? (Y/N)	N/A	N/A	DWS Offset (in)	N/A
N/A	Shared Landing?	N/A			
N/A	Gutter Ponding?	N/A	N/A	Gutter Slope (%)	N/A
N/A	Gutter Lip Ht (in)	N/A	N/A	Gutter X Slope (%)	N/A
N/A	Painted X Walk1?	No	N/A	Painted X Walk2?	No
	X Walk 1 Direction	To SW		X Walk 2 Direction	To SE
N/A	X Walk 1 Width (in)	N/A	N/A	X Walk 2 Width (in)	N/A
	X Walk 1 Slope (%)	0.2		X Walk 2 Slope (%)	2.7
	X Walk 1 X Slope (%)	2.8		X Walk 2 X Slope (%)	0.7

N/A	Ramp inside XWalk1?	N/A	N/A	Ramp inside XWalk2?	N/A
	Road Slope (%)	1.2	N/A	Clear Space?	N/A
	Road X Slope (%)	2.9	N/A	Clear Space to XWalk (in)	N/A
N/A	Any Obstructions?	N/A	N/A	Storm Grate/Utility Hazard?	N/A
	Obstruction Type			Storm Grate/Utility Type	
		N/A			N/A
		Yes		Surface Condition? (G/P)	Good

**Remove & Replace Curb Ramp With Two New Directional Ramps or Equivalent.**

Total Cost: \$ 3200.00
