Access Compliance Report

Public Rights-of-Way

(Curb Ramps)

Intersection ID: 53415	Main Street: PROVIDENCE_RD	Cross Street: SOUTHGROVE_ST	Location: SW
ADA ID: A76F9A7A4CDF	Ramp Type: Para	Initial Pass/Fail: Fail	Overall Compliance: No
Severity Score: 26.25			
Codes/Mitigation Info/Possible Solution		Field Measurements/Component Compliance

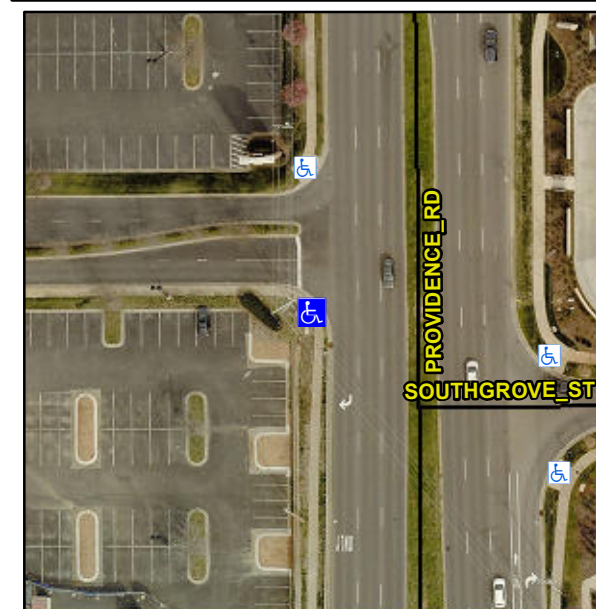
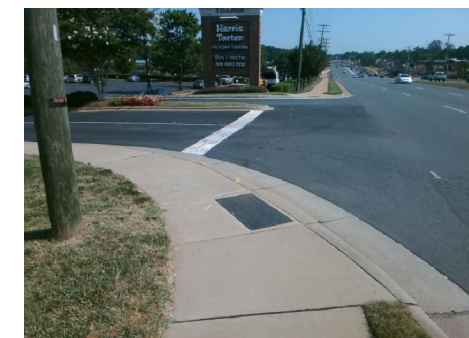
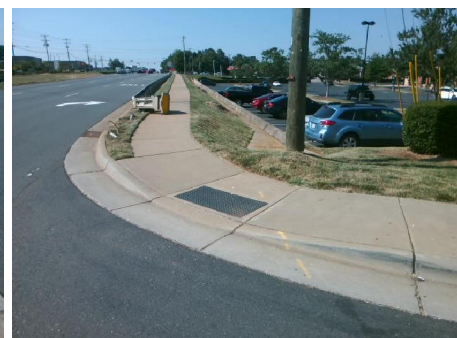
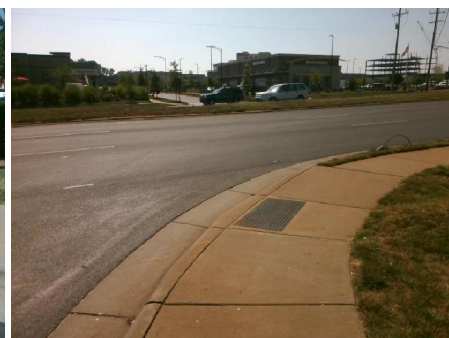
R304.3.2, R304.5.3

Compliance	Description	Data	Compliance	Description	Data
N/A	Ramp Length LT (in)	58.0	N/A	Ramp Length RT (in)	54.0
Yes	Ramp Width LT (in)	68.0	Yes	Ramp Width RT (in)	68.0
No	Ramp Slope LT (%)	13.3	Yes	Ramp Slope RT (%)	5.1
Yes	Ramp XSlope LT (%)	1.1	No	Ramp XSlope RT (%)	2.3
N/A	Landing Length (in)	N/A	N/A	DWS Provided?	N/A
N/A	Landing Width (in)	N/A	N/A	DWS Contrast?	N/A
N/A	Landing Slope (%)	N/A	N/A	DWS Length (in)	N/A
N/A	Landing X Slope (%)	N/A	N/A	DWS Full Width?	N/A
N/A	Landing Curb? (Y/N)	N/A	N/A	DWS Offset (in)	N/A
N/A	Shared Landing?	N/A			
N/A	Gutter Ponding?	N/A	N/A	Gutter Slope (%)	N/A
N/A	Gutter Lip Ht (in)	N/A	N/A	Gutter X Slope (%)	N/A
N/A	Painted X Walk1?	No	N/A	Painted X Walk2?	N/A
	X Walk 1 Direction	To N		X Walk 2 Direction	N/A
N/A	X Walk 1 Width (in)	N/A	N/A	X Walk 2 Width (in)	N/A
	X Walk 1 Slope (%)	0.8		X Walk 2 Slope (%)	N/A
	X Walk 1 X Slope (%)	0.5		X Walk 2 X Slope (%)	N/A
N/A	Ramp inside XWalk1?	N/A	N/A	Ramp inside XWalk2?	N/A

Road Slope (%)	N/A	N/A	Clear Space?	N/A
	Road X Slope (%)	N/A	N/A	Clear Space to XWalk (in)	N/A
N/A	Any Obstructions?	N/A	N/A	Storm Grate/Utility Hazard?	N/A
	Obstruction Type			Storm Grate/Utility Type	
		N/A			N/A
			Yes	Surface Condition? (G/P)	Good
			N/A	Curb Slope (%)	4.8

Remove & Replace Entire Ramp.
