Intersection ID: 23898		Main Street: LONGHEDGE_LN		Cross Street: MOSS_RD		Location:		NW									
ADA ID: A77A3176252F		Ramp Type: PerpDiag		Initial Pass/Fail: Fail		Overall Compliance: No		Severity Score: 13.75									
Codes/Mitigation Info/Possible Solution				Field Measurements/Component Compliance

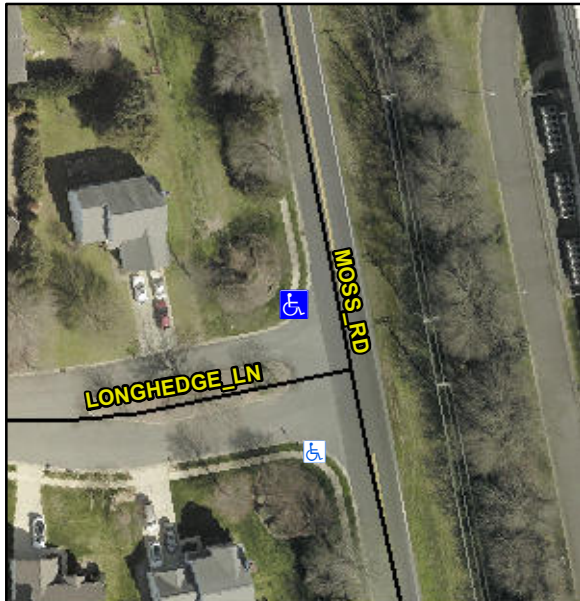
Surveyor Notes: N/A		N/A		Landing Length (in)		N/A		N/A		DWS Provided?		N/A	
						N/A		Landing Width (in)		N/A		N/A		DWS Contrast?		N/A	
						N/A		Landing Slope (%)		N/A		N/A		DWS Length (in)		N/A	
						N/A		Landing X Slope (%)		N/A		N/A		DWS Full Width?		N/A	
N/A		Landing Curb? (Y/N)				N/A		N/A		DWS Offset (in)		N/A					
PROW/ADA: Not Found, R304.2.2, R304.5.3		N/A		Shared Landing?		N/A											
		N/A		Gutter Ponding?		N/A		N/A		Gutter Slope (%)		N/A					
		N/A		Gutter Lip Ht (in)		N/A		N/A		Gutter X Slope (%)		N/A					
		N/A		Painted X Walk1?		No		N/A		Painted X Walk2?		No					
				X Walk 1 Direction		To S				X Walk 2 Direction		To E					
		N/A		X Walk 1 Width (in)		N/A		N/A		X Walk 2 Width (in)		N/A					
				X Walk 1 Slope (%)		1.0				X Walk 2 Slope (%)		4.4					
				X Walk 1 X Slope (%)		2.6				X Walk 2 X Slope (%)		0.9					
		N/A		Ramp inside XWalk1?		N/A		N/A		Ramp inside XWalk2?		N/A

<div>Street 1 NameLONGHEDGE LN</div> <div>Stop Condition-Street 2StopSign</div> <div>Street 2 NameMOSS RD</div> <div>Stop Condition-Street 1None</div>				Possible Solutions:		Compliance		Description		Data		Compliance		Description		Data	
				Remove & Replace Curb Ramp With Two New Directional Ramps or Equivalent.		N/A		Ramp Length (in)		48.0		No		Ramp Slope (%)		11.0	
						Yes		Ramp Width (in)		48.0		No		Ramp XSlope (%)		3.7	
						N/A		Flare Type LT		N/A		N/A		Flare Type RT		N/A	
						N/A		Flare Slope LT (%)		N/A		N/A		Flare Slope RT (%)		N/A	
						N/A		Flare Traversable LT?		N/A		N/A		Flare Traversable RT?		N/A

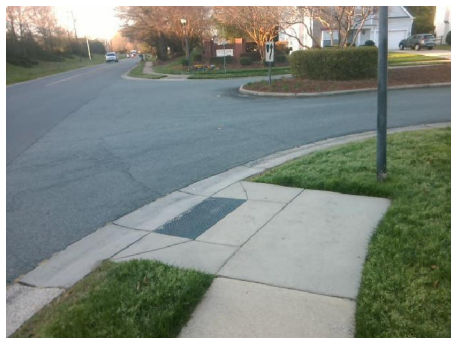
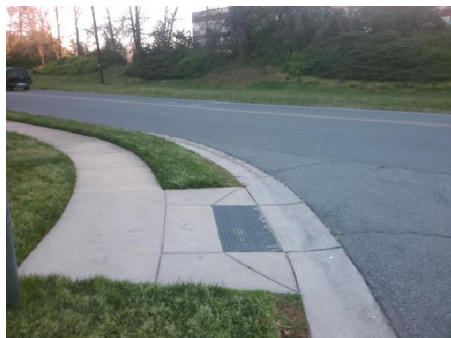
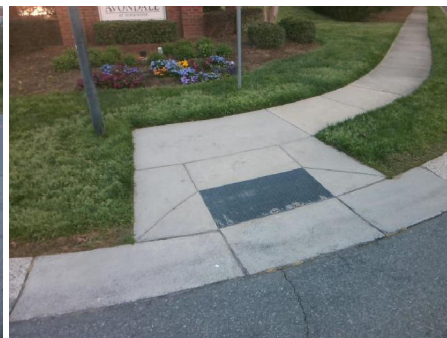
Road Slope (%)		1.4		N/A		Clear Space?		N/A					
		Road X Slope (%)		3.0		N/A		Clear Space to XWalk (in)		N/A							
		N/A		Any Obstructions?		N/A		N/A		Storm Grate/Utility Hazard?		N/A					
				Obstruction Type						Storm Grate/Utility Type							
						N/A				N/A							
								Yes		Surface Condition? (G/P)		Good					
Total Cost:		\$ 3200.00
