# Access Compliance Report

## Public Rights-of-Way

### (Curb Ramps)

Intersection ID: 11543	Main Street: GRACE_ST	Cross Street: LOLA_AV	Location: NW
ADA ID: A786BA32431A	Ramp Type: PerpDiag	Initial Pass/Fail: Fail	Overall Compliance: No
		Severity Score: 42.5

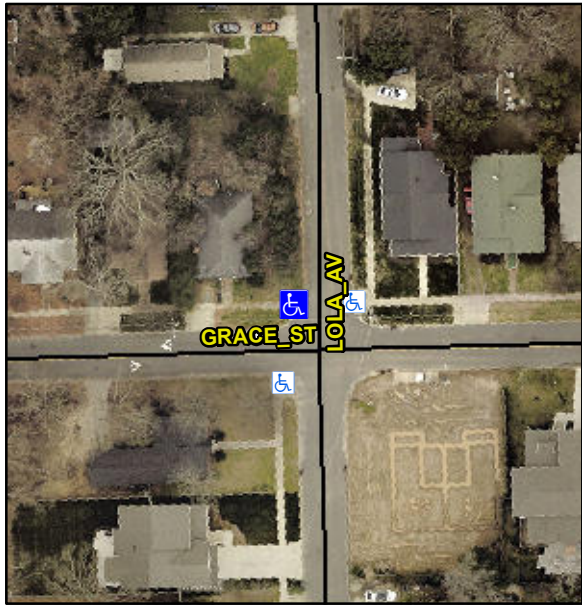
</div> <div>Street 1 NameGRACE ST</div> <div>Stop Condition-Street 2None</div> <div>Street 2 NameLOLA AV</div> <div>Stop Condition-Street 1StopSign</div>			Possible Solutions:			Compliance			Description			Data	
			Remove & Replace Curb Ramp With Two New Directional Ramps or Equivalent.			N/A	Ramp Length (in)	60.0	Yes	Ramp Slope (%)	6.5		
						No	Ramp Width (in)	34.0	No	Ramp XSlope (%)	11.2		
						N/A	Flare Type LT	N/A	N/A	Flare Type RT	N/A		
						N/A	Flare Slope LT (%)	N/A	N/A	Flare Slope RT (%)	N/A		
						N/A	Flare Traversable LT?	N/A	N/A	Flare Traversable RT?	N/A		
						N/A	Landing Length (in)	N/A	N/A	DWS Provided?	N/A		
						N/A	Landing Width (in)	N/A	N/A	DWS Contrast?	N/A		
						N/A	Landing Slope (%)	N/A	N/A	DWS Length (in)	N/A		
						N/A	Landing X Slope (%)	N/A	N/A	DWS Full Width?	N/A		
Surveyor Notes:  N/A			N/A	Landing Curb? (Y/N)	N/A	N/A	DWS Offset (in)	N/A

N/A	Shared Landing?	N/A								
			N/A	Gutter Ponding?	N/A	N/A	Gutter Slope (%)	N/A					
			N/A	Gutter Lip Ht (in)	N/A	N/A	Gutter X Slope (%)	N/A					
			N/A	Painted X Walk1?	No	N/A	Painted X Walk2?	No					
				X Walk 1 Direction	To S		X Walk 2 Direction	To E					
			N/A	X Walk 1 Width (in)	N/A	N/A	X Walk 2 Width (in)	N/A					
				X Walk 1 Slope (%)	7.6		X Walk 2 Slope (%)	1.2					
				X Walk 1 X Slope (%)	0.2		X Walk 2 X Slope (%)	8.0					
			N/A	Ramp inside XWalk1?	N/A	N/A	Ramp inside XWalk2?	N/A					
PROW/ADA:  R304.5.1, R304.5.3				Road Slope (%)	7.0	N/A	Clear Space?	N/A					
				Road X Slope (%)	6.8	N/A	Clear Space to XWalk (in)	N/A					
			N/A	Any Obstructions?	N/A	N/A	Storm Grate/Utility Hazard?	N/A					
				Obstruction Type			Storm Grate/Utility Type						
					N/A			N/A					
						Yes	Surface Condition? (G/P)	Good
