Access Compliance Report

Public Rights-of-Way

(Curb Ramps)

Intersection ID: 14378	Main Street: WORTHINGTON_AV	Cross Street: EUCLID_AV	Location:	E
ADA ID: A787959D2F05	Ramp Type: Perp	Initial Pass/Fail: Fail	Overall Compliance: No	Severity Score: 10
Codes/Mitigation Info/Possible Solution		Field Measurements/Component Compliance

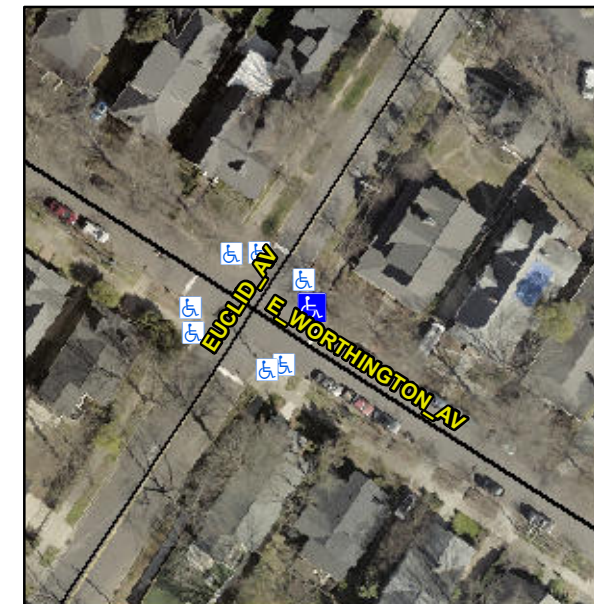
Not Found, R304.5.1, R304.5.3

Compliance	Description	Data	Compliance	Description	Data
N/A	Ramp Length (in)	109.0	Yes	Ramp Slope (%)	5.1
No	Ramp Width (in)	47.0	No	Ramp XSlope (%)	2.4
N/A	Flare Type LT	N/A	N/A	Flare Type RT	N/A
N/A	Flare Slope LT (%)	N/A	N/A	Flare Slope RT (%)	N/A
N/A	Flare Traversable LT?	N/A	N/A	Flare Traversable RT?	N/A
N/A	Landing Length (in)	N/A	N/A	DWS Provided?	N/A
N/A	Landing Width (in)	N/A	N/A	DWS Contrast?	N/A
N/A	Landing Slope (%)	N/A	N/A	DWS Length (in)	N/A
N/A	Landing X Slope (%)	N/A	N/A	DWS Full Width?	N/A
N/A	Landing Curb? (Y/N)	N/A	N/A	DWS Offset (in)	N/A
N/A	Shared Landing?	N/A			
N/A	Gutter Ponding?	N/A	N/A	Gutter Slope (%)	N/A
N/A	Gutter Lip Ht (in)	N/A	N/A	Gutter X Slope (%)	N/A
N/A	Painted X Walk1?	No	N/A	Painted X Walk2?	N/A
	X Walk 1 Direction	To SW		X Walk 2 Direction	N/A
N/A	X Walk 1 Width (in)	N/A	N/A	X Walk 2 Width (in)	N/A
	X Walk 1 Slope (%)	3.7		X Walk 2 Slope (%)	N/A
	X Walk 1 X Slope (%)	1.2		X Walk 2 X Slope (%)	N/A

N/A	Ramp inside XWalk1?	N/A	N/A	Ramp inside XWalk2?	N/A
	Road Slope (%)	N/A	N/A	Clear Space?	N/A
	Road X Slope (%)	N/A	N/A	Clear Space to XWalk (in)	N/A
N/A	Any Obstructions?	N/A	N/A	Storm Grate/Utility Hazard?	N/A
	Obstruction Type			Storm Grate/Utility Type	
		N/A			N/A
			Yes	Surface Condition? (G/P)	Good

Remove & Replace Entire Ramp.
