Access Compliance Report

Public Rights-of-Way

(Curb Ramps)

Intersection ID: 48494	Main Street: MELFORT_WY	Cross Street: BEREWICK_COMMONS_PY	Location: SE
ADA ID: A799634923E3	Ramp Type: Perp	Initial Pass/Fail: Fail	Overall Compliance: No
Codes/Mitigation Info/Possible Solution			Severity Score: 12.5
Field Measurements/Component Compliance

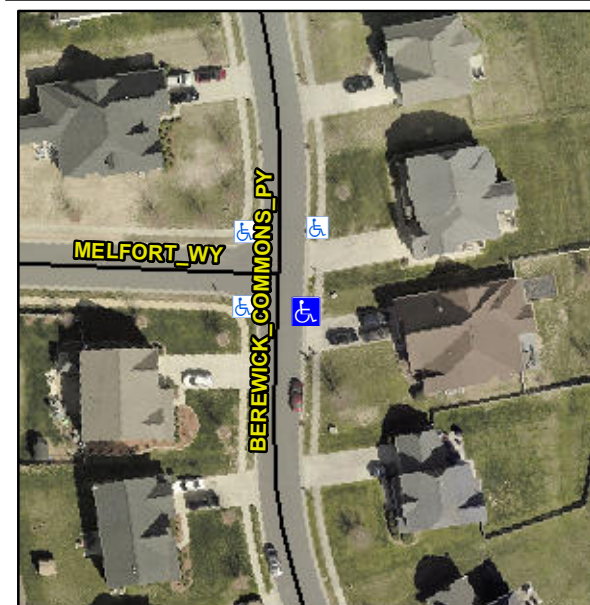
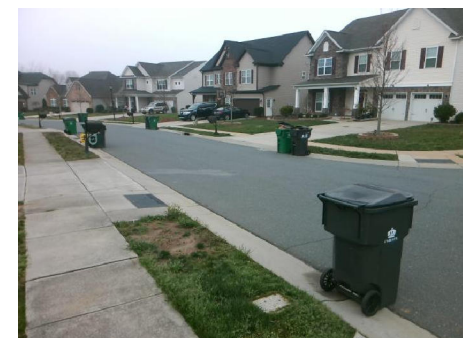
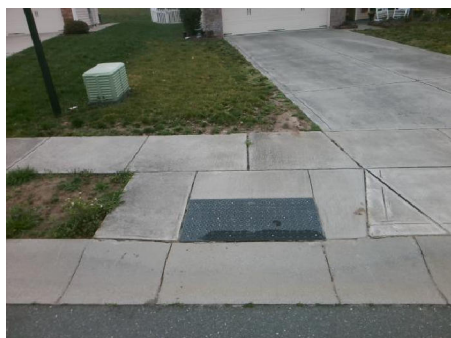
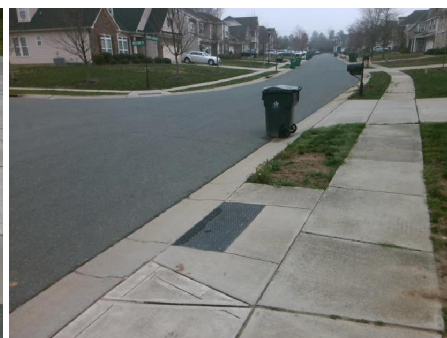
Not Found, R304.2.2

Compliance	Description	Data	Compliance	Description	Data
N/A	Ramp Length (in)	47.0	No	Ramp Slope (%)	8.6
Yes	Ramp Width (in)	48.0	Yes	Ramp XSlope (%)	2.0
N/A	Flare Type LT	N/A	N/A	Flare Type RT	N/A
N/A	Flare Slope LT (%)	N/A	N/A	Flare Slope RT (%)	N/A
N/A	Flare Traversable LT?	N/A	N/A	Flare Traversable RT?	N/A
N/A	Landing Length (in)	N/A	N/A	DWS Provided?	N/A
N/A	Landing Width (in)	N/A	N/A	DWS Contrast?	N/A
N/A	Landing Slope (%)	N/A	N/A	DWS Length (in)	N/A
N/A	Landing X Slope (%)	N/A	N/A	DWS Full Width?	N/A
N/A	Landing Curb? (Y/N)	N/A	N/A	DWS Offset (in)	N/A
N/A	Shared Landing?	N/A			
N/A	Gutter Ponding?	N/A	N/A	Gutter Slope (%)	N/A
N/A	Gutter Lip Ht (in)	N/A	N/A	Gutter X Slope (%)	N/A
N/A	Painted X Walk1?	No	N/A	Painted X Walk2?	N/A
	X Walk 1 Direction	To NW		X Walk 2 Direction	N/A
N/A	X Walk 1 Width (in)	N/A	N/A	X Walk 2 Width (in)	N/A
	X Walk 1 Slope (%)	4.1		X Walk 2 Slope (%)	N/A
	X Walk 1 X Slope (%)	3.0		X Walk 2 X Slope (%)	N/A

N/A	Ramp inside XWalk1?	N/A	N/A	Ramp inside XWalk2?	N/A
	Road Slope (%)	N/A	N/A	Clear Space?	N/A
	Road X Slope (%)	N/A	N/A	Clear Space to XWalk (in)	N/A
N/A	Any Obstructions?	N/A	N/A	Storm Grate/Utility Hazard?	N/A
	Obstruction Type			Storm Grate/Utility Type	
		N/A			N/A
			Yes	Surface Condition? (G/P)	Good

Remove & Replace Entire Ramp.
