Access Compliance Report

Public Rights-of-Way

(Curb Ramps)

Intersection ID: 20860	Main Street: CROWNPOINT_EXECUTIVE_DR	Cross Street: KREFELD_DR	Location: SW
ADA ID: A7B6F8EDFC60	Ramp Type: PerpDiag	Initial Pass/Fail: Fail	Overall Compliance: No
Severity Score: 8.75			
Codes/Mitigation Info/Possible Solution		Field Measurements/Component Compliance

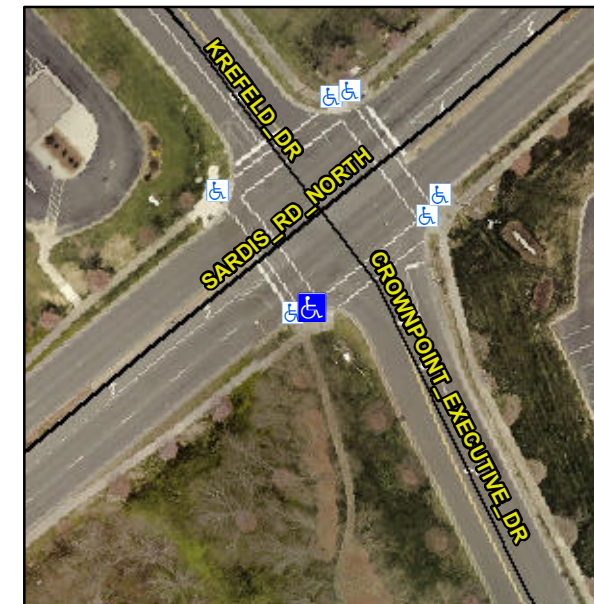
Not Found, R304.5.1

Compliance	Description	Data	Compliance	Description	Data
N/A	Ramp Length (in)	64.0	Yes	Ramp Slope (%)	8.3
No	Ramp Width (in)	42.0	Yes	Ramp XSlope (%)	0.6
N/A	Flare Type LT	N/A	N/A	Flare Type RT	N/A
N/A	Flare Slope LT (%)	N/A	N/A	Flare Slope RT (%)	N/A
N/A	Flare Traversable LT?	N/A	N/A	Flare Traversable RT?	N/A
N/A	Landing Length (in)	N/A	N/A	DWS Provided?	N/A
N/A	Landing Width (in)	N/A	N/A	DWS Contrast?	N/A
N/A	Landing Slope (%)	N/A	N/A	DWS Length (in)	N/A
N/A	Landing X Slope (%)	N/A	N/A	DWS Full Width?	N/A
N/A	Landing Curb? (Y/N)	N/A	N/A	DWS Offset (in)	N/A
N/A	Shared Landing?	N/A			
N/A	Gutter Ponding?	N/A	N/A	Gutter Slope (%)	N/A
N/A	Gutter Lip Ht (in)	N/A	N/A	Gutter X Slope (%)	N/A
N/A	Painted X Walk1?	Yes	N/A	Painted X Walk2?	Yes
	X Walk 1 Direction	To NE		X Walk 2 Direction	To NW
N/A	X Walk 1 Width (in)	105.0	N/A	X Walk 2 Width (in)	117.0
	X Walk 1 Slope (%)	4.4		X Walk 2 Slope (%)	0.0
	X Walk 1 X Slope (%)	3.7		X Walk 2 X Slope (%)	2.4

N/A	Ramp inside XWalk1?	Yes	N/A	Ramp inside XWalk2?	Yes
	Road Slope (%)	0.3	N/A	Clear Space?	N/A
	Road X Slope (%)	6.6	N/A	Clear Space to XWalk (in)	N/A
N/A	Any Obstructions?	N/A	N/A	Storm Grate/Utility Hazard?	N/A
	Obstruction Type			Storm Grate/Utility Type	
		N/A			N/A
		Yes		Surface Condition? (G/P)	Good

Remove & Replace Curb Ramp With Two New Directional Ramps or Equivalent.
