Access Compliance Report Public Rights-of-Way (Curb Ramps)

Intersection ID: N/A Main Street: BALLANTYNE_COUNTRY_CLUB_DR Cross Street: COYLE_CR Location: SE

ADA ID: A7C299B0E9AB Ramp Type: Perp Initial Pass/Fail: Fail Overall Compliance: No Severity Score: 13.75

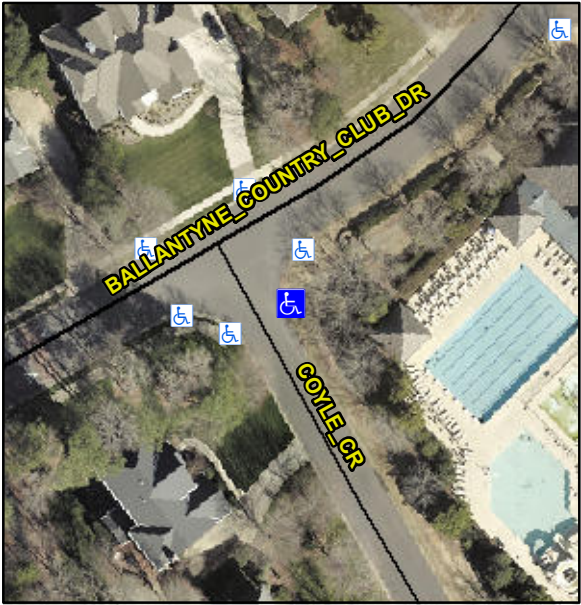
PROW/ADA:
Not Found, R304.2.2, R304.5.3

Compliance	Description	Data	Compliance	Description	Data
N/A	Ramp Length (in)	64.0	No	Ramp Slope (%)	8.8
Yes	Ramp Width (in)	48.0	No	Ramp XSlope (%)	2.7
N/A	Flare Type LT	N/A	N/A	Flare Type RT	N/A
N/A	Flare Slope LT (%)	N/A	N/A	Flare Slope RT (%)	N/A
N/A	Flare Traversable LT?	N/A	N/A	Flare Traversable RT?	N/A
N/A	Landing Length (in)	N/A	N/A	DWS Provided?	N/A
N/A	Landing Width (in)	N/A	N/A	DWS Contrast?	N/A
N/A	Landing Slope (%)	N/A	N/A	DWS Length (in)	N/A
N/A	Landing X Slope (%)	N/A	N/A	DWS Full Width?	N/A
N/A	Landing Curb? (Y/N)	N/A	N/A	DWS Offset (in)	N/A
N/A	Shared Landing?	N/A			
N/A	Gutter Ponding?	N/A	N/A	Gutter Slope (%)	N/A
N/A	Gutter Lip Ht (in)	N/A	N/A	Gutter X Slope (%)	N/A
N/A	Painted X Walk1?	No	N/A	Painted X Walk2?	N/A
	X Walk 1 Direction	To SW		X Walk 2 Direction	N/A
N/A	X Walk 1 Width (in)	N/A	N/A	X Walk 2 Width (in)	N/A
	X Walk 1 Slope (%)	0.9		X Walk 2 Slope (%)	N/A
	X Walk 1 X Slope (%)	1.8		X Walk 2 X Slope (%)	N/A

N/A	Ramp inside XWalk1?	N/A	N/A	Ramp inside XWalk2?	N/A
	Road Slope (%)	N/A	N/A	Clear Space?	N/A
	Road X Slope (%)	N/A	N/A	Clear Space to XWalk (in)	N/A
N/A	Any Obstructions?	N/A	N/A	Storm Grate/Utility Hazard?	N/A
	Obstruction Type			Storm Grate/Utility Type	
			N/A		N/A
			Yes	Surface Condition? (G/P)	Good

Possible Solutions:
Remove & Replace Entire Ramp.

Total Cost: \$ 1850.00
