## **Access Compliance Report Public Rights-of-Way** (Curb Ramps)

Intersection ID: 17138 Main Street: IDLEWILD RD **Cross Street: PINEY GROVE RD** Location: NE ADA ID: A7C6A370C83B Ramp Type: Para Initial Pass/Fail: Fail **Overall Compliance: No** Severity Score: 13.75

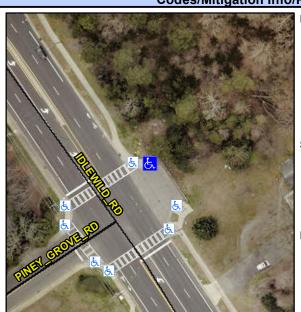
Compliance Description Data		Data	Compliance Description		Data
N/A	Ramp Length LT (in)	48.0	N/A	Ramp Length RT (in)	N/A
Yes	Ramp Width LT (in)	84.0	N/A	Ramp Width RT (in)	N/A
No	Ramp Slope LT (%)	8.9	N/A	Ramp Slope RT (%)	N/A
No	Ramp XSlope LT (%)	3.5	N/A	Ramp XSlope RT (%)	N/A
N/A	Landing Length (in)	N/A	N/A	DWS Provided?	N/A
N/A	Landing Width (in)	N/A	N/A	DWS Contrast?	N/A
N/A	Landing Slope (%)	N/A	N/A	DWS Length (in)	N/A
N/A	Landing X Slope (%)	N/A	N/A	DWS Full Width?	N/A
N/A	Landing Curb? (Y/N)	N/A	N/A	DWS Offset (in)	N/A
N/A	Shared Landing?	N/A			
N/A	Gutter Ponding?	N/A	N/A	Gutter Slope (%)	N/A
N/A	Gutter Lip Ht (in)	N/A	N/A	Gutter X Slope (%)	N/A
N/A	Painted X Walk1?	No	N/A	Painted X Walk2?	N/A
	X Walk 1 Direction	To SE		X Walk 2 Direction	N/A
N/A	X Walk 1 Width (in)	N/A	N/A	X Walk 2 Width (in)	N/A
	X Walk 1 Slope (%)	2.7		X Walk 2 Slope (%)	N/A
	X Walk 1 X Slope (%)	1.9		X Walk 2 X Slope (%)	N/A
N/A	Ramp inside XWalk1?	N/A	N/A	Ramp inside XWalk2?	N/A

Road Slope (%)	N/A	N/A	Clear Space?	N/A
	Road X Slope (%)	N/A	N/A	Clear Space to XWalk (in)	N/A
N/A	Any Obstructions?	N/A	N/A	Storm Grate/Utility Hazard?	N/A
	Obstruction Type			Storm Grate/Utility Type	
		N/A			N/A
			Yes	Surface Condition? (G/P)	Good
			N/A	Curb Slope (%)	2.8

**PINEY GROVE RD** Street 1 Name Stop Condition-Street 1 None Street 2 Name N/A Stop Condition-Street 2 N/A Possible Solutions: Remove & Replace Entire Ramp. Surveyor Notes: N/A PROW/ADA: R304.3.2, R304.5.3
