# Access Compliance Report

## Public Rights-of-Way

### (Curb Ramps)

Intersection ID: 47849	Main Street: SERAPE_RD	Cross Street: STONE_PORCH_RD	Location: NW
ADA ID: A7F7ECCB26A3	Ramp Type: PerpDiag	Initial Pass/Fail: Fail	Overall Compliance: No
Severity Score: 8.75			
Codes/Mitigation Info/Possible Solution		Field Measurements/Component Compliance

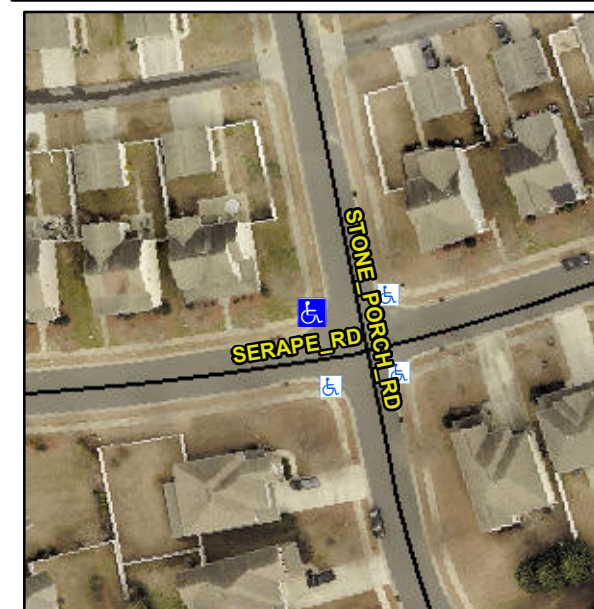
Compliance	Description	Data	Compliance	Description	Data
N/A	Ramp Length (in)	52.0	Yes	Ramp Slope (%)	5.1
No	Ramp Width (in)	44.0	Yes	Ramp XSlope (%)	0.2
N/A	Flare Type LT	N/A	N/A	Flare Type RT	N/A
N/A	Flare Slope LT (%)	N/A	N/A	Flare Slope RT (%)	N/A
N/A	Flare Traversable LT?	N/A	N/A	Flare Traversable RT?	N/A
N/A	Landing Length (in)	N/A	N/A	DWS Provided?	N/A
N/A	Landing Width (in)	N/A	N/A	DWS Contrast?	N/A
N/A	Landing Slope (%)	N/A	N/A	DWS Length (in)	N/A
N/A	Landing X Slope (%)	N/A	N/A	DWS Full Width?	N/A
N/A	Landing Curb? (Y/N)	N/A	N/A	DWS Offset (in)	N/A
N/A	Shared Landing?	N/A			
N/A	Gutter Ponding?	N/A	N/A	Gutter Slope (%)	N/A
N/A	Gutter Lip Ht (in)	N/A	N/A	Gutter X Slope (%)	N/A
N/A	Painted X Walk1?	No	N/A	Painted X Walk2?	No
	X Walk 1 Direction	To S		X Walk 2 Direction	To E
N/A	X Walk 1 Width (in)	N/A	N/A	X Walk 2 Width (in)	N/A
	X Walk 1 Slope (%)	1.8		X Walk 2 Slope (%)	0.2
	X Walk 1 X Slope (%)	0.2		X Walk 2 X Slope (%)	1.7

N/A	Ramp inside XWalk1?	N/A	N/A	Ramp inside XWalk2?	N/A
	Road Slope (%)	1.8	N/A	Clear Space?	N/A
	Road X Slope (%)	1.1	N/A	Clear Space to XWalk (in)	N/A
N/A	Any Obstructions?	N/A	N/A	Storm Grate/Utility Hazard?	N/A
	Obstruction Type			Storm Grate/Utility Type	
		N/A			N/A
		Yes		Surface Condition? (G/P)	Good

Possible Solutions:

**Remove & Replace Curb Ramp With Two New Directional Ramps or Equivalent.**

**Not Found, R304.5.1**
