# Access Compliance Report

## Public Rights-of-Way

### (Curb Ramps)

Intersection ID: 47449	Main Street: MALLARD_LANDING_RD	Cross Street: WOOD_DUCK_CROSSING_DR	Location: SE
ADA ID: A7FF2610B9C7	Ramp Type: PerpDiag	Initial Pass/Fail: Fail	Overall Compliance: No
Severity Score: 12.5			
Codes/Mitigation Info/Possible Solution		Field Measurements/Component Compliance

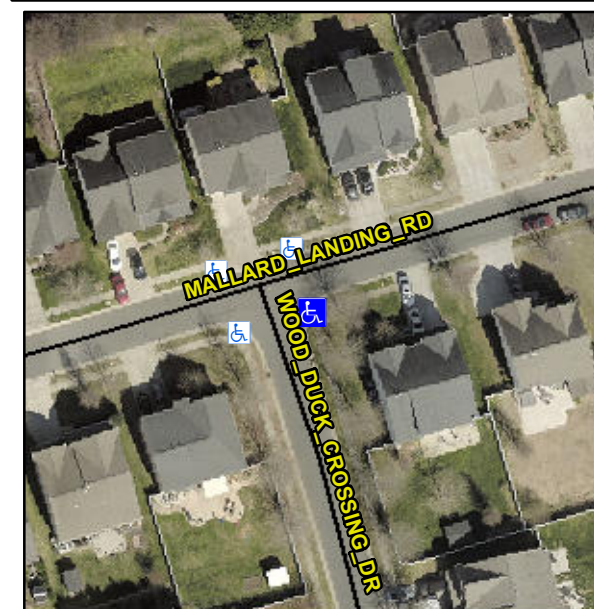
**Not Found, R304.2.2**

Compliance	Description	Data	Compliance	Description	Data
N/A	Ramp Length (in)	49.5	No	Ramp Slope (%)	8.4
Yes	Ramp Width (in)	48.5	Yes	Ramp XSlope (%)	1.6
N/A	Flare Type LT	N/A	N/A	Flare Type RT	N/A
N/A	Flare Slope LT (%)	N/A	N/A	Flare Slope RT (%)	N/A
N/A	Flare Traversable LT?	N/A	N/A	Flare Traversable RT?	N/A
N/A	Landing Length (in)	N/A	N/A	DWS Provided?	N/A
N/A	Landing Width (in)	N/A	N/A	DWS Contrast?	N/A
N/A	Landing Slope (%)	N/A	N/A	DWS Length (in)	N/A
N/A	Landing X Slope (%)	N/A	N/A	DWS Full Width?	N/A
N/A	Landing Curb? (Y/N)	N/A	N/A	DWS Offset (in)	N/A
N/A	Shared Landing?	N/A			
N/A	Gutter Ponding?	N/A	N/A	Gutter Slope (%)	N/A
N/A	Gutter Lip Ht (in)	N/A	N/A	Gutter X Slope (%)	N/A
N/A	Painted X Walk1?	No	N/A	Painted X Walk2?	No
	X Walk 1 Direction	To N		X Walk 2 Direction	To W
N/A	X Walk 1 Width (in)	N/A	N/A	X Walk 2 Width (in)	N/A
	X Walk 1 Slope (%)	3.9		X Walk 2 Slope (%)	4.4
	X Walk 1 X Slope (%)	3.5		X Walk 2 X Slope (%)	1.3

N/A	Ramp inside XWalk1?	N/A	N/A	Ramp inside XWalk2?	N/A
	Road Slope (%)	1.8	N/A	Clear Space?	N/A
	Road X Slope (%)	4.0	N/A	Clear Space to XWalk (in)	N/A
N/A	Any Obstructions?	N/A	N/A	Storm Grate/Utility Hazard?	N/A
	Obstruction Type			Storm Grate/Utility Type	
		N/A			N/A
		Yes		Surface Condition? (G/P)	Good

**Remove & Replace Curb Ramp With Two New Directional Ramps or Equivalent.**

Total Cost: \$ 3200.00
