Access Compliance Report

Public Rights-of-Way

(Curb Ramps)

Intersection ID: 43744	Main Street: RED_CLAY_LN	Cross Street: EARTHENWARE_DR	Location: W
ADA ID: A81066F15DE2	Ramp Type: Perp	Initial Pass/Fail: Fail	Overall Compliance: No
Severity Score: 33.75			
Codes/Mitigation Info/Possible Solution		Field Measurements/Component Compliance

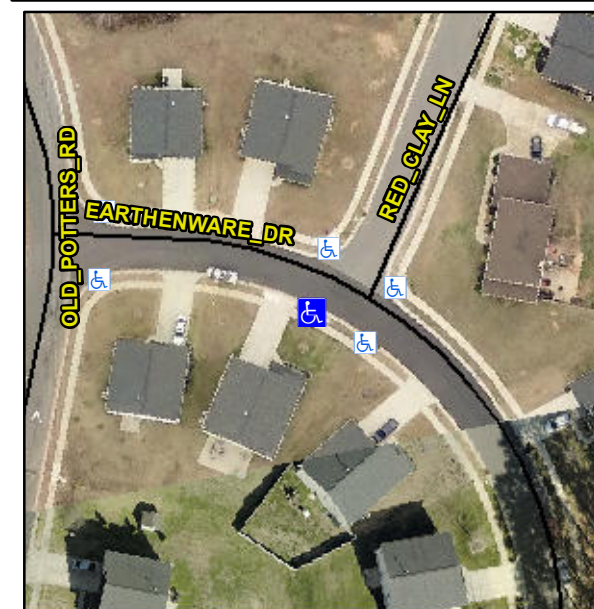
Not Found, R304.5.1, R304.2.2

Compliance	Description	Data	Compliance	Description	Data
N/A	Ramp Length (in)	48.0	No	Ramp Slope (%)	12.3
No	Ramp Width (in)	47.0	Yes	Ramp XSlope (%)	1.5
N/A	Flare Type LT	N/A	N/A	Flare Type RT	N/A
N/A	Flare Slope LT (%)	N/A	N/A	Flare Slope RT (%)	N/A
N/A	Flare Traversable LT?	N/A	N/A	Flare Traversable RT?	N/A
N/A	Landing Length (in)	N/A	N/A	DWS Provided?	N/A
N/A	Landing Width (in)	N/A	N/A	DWS Contrast?	N/A
N/A	Landing Slope (%)	N/A	N/A	DWS Length (in)	N/A
N/A	Landing X Slope (%)	N/A	N/A	DWS Full Width?	N/A
N/A	Landing Curb? (Y/N)	N/A	N/A	DWS Offset (in)	N/A
N/A	Shared Landing?	N/A			
N/A	Gutter Ponding?	N/A	N/A	Gutter Slope (%)	N/A
N/A	Gutter Lip Ht (in)	N/A	N/A	Gutter X Slope (%)	N/A
N/A	Painted X Walk1?	No	N/A	Painted X Walk2?	N/A
	X Walk 1 Direction	To NE		X Walk 2 Direction	N/A
N/A	X Walk 1 Width (in)	N/A	N/A	X Walk 2 Width (in)	N/A
	X Walk 1 Slope (%)	3.9		X Walk 2 Slope (%)	N/A
	X Walk 1 X Slope (%)	1.2		X Walk 2 X Slope (%)	N/A

N/A	Ramp inside XWalk1?	N/A	N/A	Ramp inside XWalk2?	N/A
	Road Slope (%)	N/A	N/A	Clear Space?	N/A
	Road X Slope (%)	N/A	N/A	Clear Space to XWalk (in)	N/A
N/A	Any Obstructions?	N/A	N/A	Storm Grate/Utility Hazard?	N/A
	Obstruction Type			Storm Grate/Utility Type	
		N/A			N/A
			Yes	Surface Condition? (G/P)	Good

Possible Solutions:

Remove & Replace Entire Ramp.

Total Cost: \$ 1850.00
