Access Compliance Report

Public Rights-of-Way

(Curb Ramps)

Intersection ID: 8749	Main Street: BARRINGTON_DR	Cross Street: OLD_COACH_RD	Location: S
ADA ID: A8167E9B7A48	Ramp Type: Perp	Initial Pass/Fail: Fail	Overall Compliance: No
Severity Score: 13.75			
Codes/Mitigation Info/Possible Solution		Field Measurements/Component Compliance

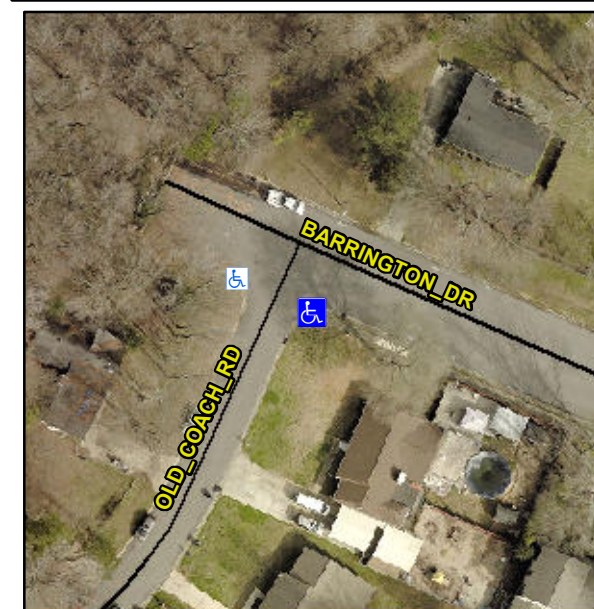
Not Found, R304.2.2, R304.5.3

Compliance	Description	Data	Compliance	Description	Data
N/A	Ramp Length (in)	28.0	No	Ramp Slope (%)	10.7
Yes	Ramp Width (in)	48.0	No	Ramp XSlope (%)	2.9
N/A	Flare Type LT	N/A	N/A	Flare Type RT	N/A
N/A	Flare Slope LT (%)	N/A	N/A	Flare Slope RT (%)	N/A
N/A	Flare Traversable LT?	N/A	N/A	Flare Traversable RT?	N/A
N/A	Landing Length (in)	N/A	N/A	DWS Provided?	N/A
N/A	Landing Width (in)	N/A	N/A	DWS Contrast?	N/A
N/A	Landing Slope (%)	N/A	N/A	DWS Length (in)	N/A
N/A	Landing X Slope (%)	N/A	N/A	DWS Full Width?	N/A
N/A	Landing Curb? (Y/N)	N/A	N/A	DWS Offset (in)	N/A
N/A	Shared Landing?	N/A			
N/A	Gutter Ponding?	N/A	N/A	Gutter Slope (%)	N/A
N/A	Gutter Lip Ht (in)	1.0	N/A	Gutter X Slope (%)	N/A
N/A	Painted X Walk1?	No	N/A	Painted X Walk2?	N/A
	X Walk 1 Direction	To NW		X Walk 2 Direction	N/A
N/A	X Walk 1 Width (in)	N/A	N/A	X Walk 2 Width (in)	N/A
	X Walk 1 Slope (%)	2.6		X Walk 2 Slope (%)	N/A
	X Walk 1 X Slope (%)	0.4		X Walk 2 X Slope (%)	N/A

N/A	Ramp inside XWalk1?	N/A	N/A	Ramp inside XWalk2?	N/A
	Road Slope (%)	N/A	N/A	Clear Space?	N/A
	Road X Slope (%)	N/A	N/A	Clear Space to XWalk (in)	N/A
N/A	Any Obstructions?	N/A	N/A	Storm Grate/Utility Hazard?	N/A
	Obstruction Type			Storm Grate/Utility Type	
		N/A			N/A
			Yes	Surface Condition? (G/P)	Good

Possible Solutions:

Remove & Replace Entire Ramp.
