Access Compliance Report Public Rights-of-Way (Curb Ramps)

Intersection ID: 13404 Main Street: LEXINGTON_AV Cross Street: E_CARSON_BV Location: SE

ADA ID: A81B7B9285F5 Ramp Type: Perp Initial Pass/Fail: Fail Overall Compliance: No Severity Score: 10

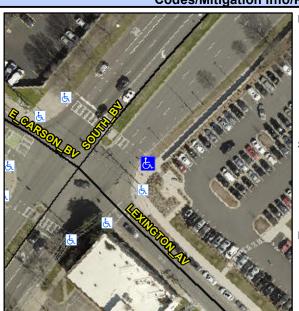
Fleid Measurements/Component Compliance						
Comp	liance Description	Data	Compl	iance	Description	Data
N/A	Ramp Length (in)	96.0	Yes	Ramp	Slope (%)	6.0
No	Ramp Width (in)	45.5	No	Ramp	xSlope (%)	3.3
N/A	Flare Type LT	N/A	N/A	Flare	Type RT	N/A
N/A	Flare Slope LT (%)	N/A	N/A	Flare	Slope RT (%)	N/A
N/A	Flare Traversable LT?	N/A	N/A	Flare	Traversable RT?	N/A
N/A	Landing Length (in)	N/A	N/A	DWS	Provided?	N/A
N/A	Landing Width (in)	N/A	N/A	DWS	Contrast?	N/A
N/A	Landing Slope (%)	N/A	N/A	DWS	Length (in)	N/A
N/A	Landing X Slope (%)	N/A	N/A	DWS	Full Width?	N/A
N/A	Landing Curb? (Y/N)	N/A	N/A	DWS	Offset (in)	N/A
N/A	Shared Landing?	N/A				
N/A	Gutter Ponding?	Yes	N/A	Gutte	er Slope (%)	N/A
N/A	Gutter Lip Ht (in)	N/A	N/A	Gutte	er X Slope (%)	N/A
N/A	Painted X Walk1?	Yes	N/A	Paint	ed X Walk2?	N/A
	X Walk 1 Direction	To NW		X Wa	lk 2 Direction	N/A
N/A	X Walk 1 Width (in)	112.0	N/A	X Wa	ılk 2 Width (in)	N/A
	X Walk 1 Slope (%)	1.1		X Wa	ılk 2 Slope (%)	N/A

X Walk 1 X Slope (%)	0.5		X Wa	ılk 2 X Slope (%)	N/A
N/A	Ramp inside XWalk1?	Yes	N/A	Ram	p inside XWalk2?	N/A
	Road Slope (%)	N/A	N/A	Clear	Space?	N/A
	Road X Slope (%)	N/A	N/A	Clear	Space to XWalk (in)	N/A
N/A	Any Obstructions?	N/A	N/A	Storn	n Grate/Utility Hazard?	N/A
	Obstruction Type			Storn	n Grate/Utility Type

Total Cost: \$ 1850.00
