# Access Compliance Report

## Public Rights-of-Way

### (Curb Ramps)

Intersection ID: N/A	Main Street: W W T HARRIS BV	Cross Street: N/A	Location: NE
ADA ID: A836F6A8034A	Ramp Type: Directional1	Initial Pass/Fail: Fail	Overall Compliance: No
		Severity Score: 52.5	
Codes/Mitigation Info/Possible Solution		Field Measurements/Component Compliance

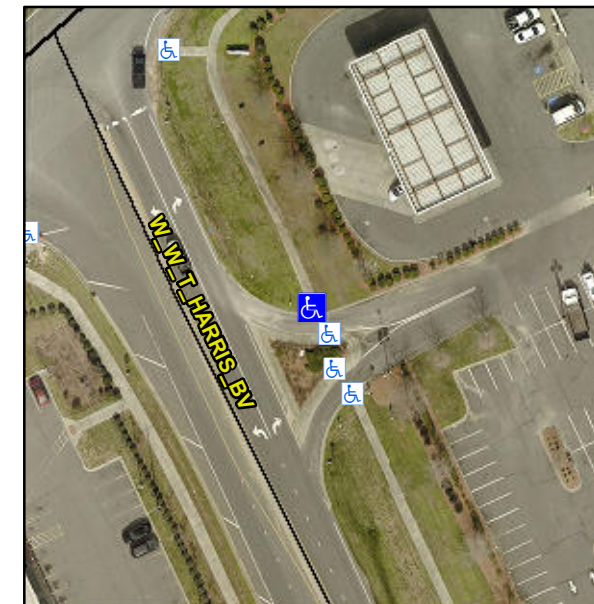
Compliance	Description	Data	Compliance	Description	Data
N/A	Ramp Length (in)	67.0	N/A	Grade Break?	N/A
Yes	Ramp Width (in)	68.0	N/A	Grade Break Slope (%)	0.0
No	Ramp Slope (%)	12.9	N/A	Grade Break XSlope (%)	0.0
No	Ramp XSlope (%)	6.0			
N/A	Flare Type LT	N/A	N/A	Flare Type RT	N/A
N/A	Flare Slope LT (%)	N/A	N/A	Flare Slope RT (%)	0.0
N/A	Flare Traversable LT?	N/A	N/A	Flare Traversable RT?	N/A
N/A	Landing Length (in)	0.0	N/A	DWS Provided?	N/A
N/A	Landing Width (in)	0.0	N/A	DWS Contrast?	N/A
N/A	Landing Slope (%)	0.0	N/A	DWS Length (in)	N/A
N/A	Landing X Slope (%)	0.0	N/A	DWS Full Width?	N/A
N/A	Landing Curb? (Y/N)	N/A	N/A	DWS Offset LT (in)	N/A
N/A	Shared Landing?	N/A	N/A	DWS Offset RT (in)	N/A
N/A	Gutter Ponding?	0.0	N/A	Gutter Slope (%)	N/A
N/A	Gutter Lip Ht (in)	0.0	N/A	Gutter X Slope (%)	N/A
N/A	Painted X Walk1?	No		Road Slope (%)	0.8
	X Walk 1 Direction	To S		Road X Slope (%)	4.8
	X Walk 1 Width (in)	N/A		Clear Space?	N/A

X Walk 1 Slope (%)	0.8	N/A	Clear Space to XWalk (in)	N/A
	X Walk 1 X Slope (%)	4.8	N/A	Storm Grate/Utility Hazard?	N/A
N/A	Ramp inside XWalk1?	N/A		Storm Grate/Utility Type	
N/A	Any Obstructions?	N/A			N/A
	Obstruction Type		No	Surface Condition? (G/P)	Poor
			N/A	Curb Slope (%)	2.1

**Remove & Replace Entire Ramp.**

**R304.2.2, R304.5.3, R302.7**

\$ 1600.00

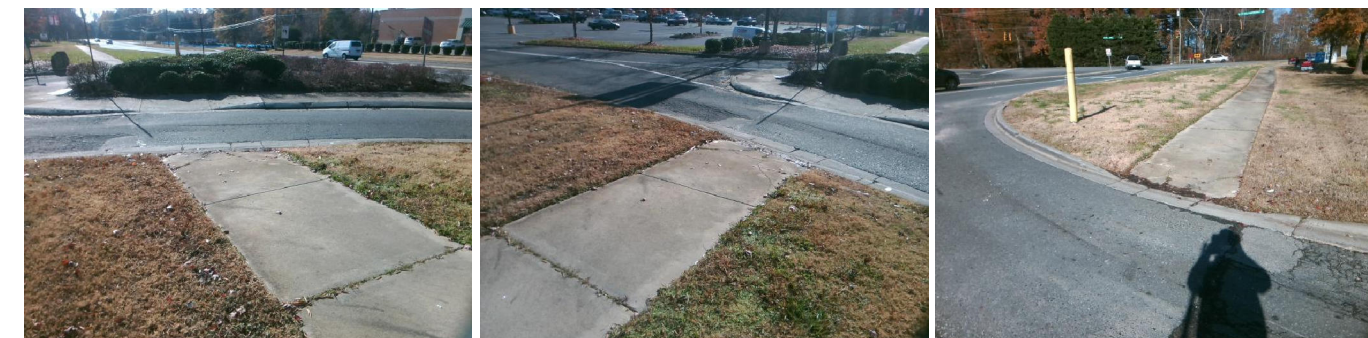
Street 1 Name	<b>ENTRANCE</b>
Stop Condition-Street 1	<b>None</b>
Street 2 Name	<b>N/A</b>
Stop Condition-Street 2	<b>N/A</b>

Possible Solutions:
