Access Compliance Report

Public Rights-of-Way

(Curb Ramps)

| Intersection ID: N/A | Main Street: INVERNESS_BAY_RD | Cross Street: DALLAS_BAY_RD | Location: NE |

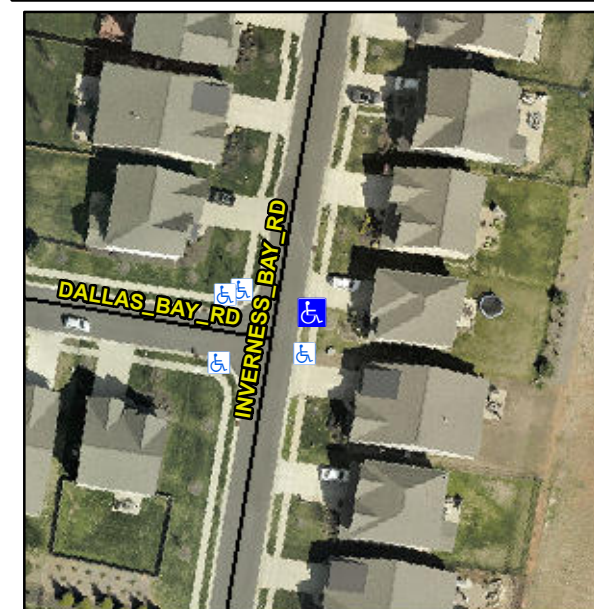
| ADA ID: A8558A615376 | Ramp Type: Perp | Initial Pass/Fail: Fail | Overall Compliance: No |

| Severity Score: 13.75 | | | |

R304.2.2

| Compliance | Description | Data | Compliance | Description | Data |
|---|---|---|---|---|---|
| N/A | Ramp Length (in) | 48.0 | No | Ramp Slope (%) | 11.6 |

Remove & Replace Entire Ramp.
