Access Compliance Report

Public Rights-of-Way

(Curb Ramps)

Intersection ID: 21378	Main Street: CAMBRIDGE BELTWAY DR	Cross Street: LENOX POINTE DR	Location: W
ADA ID: A85CC9D7AC51	Ramp Type: PerpDiag	Initial Pass/Fail: Fail	Overall Compliance: No
		Severity Score: 8.75

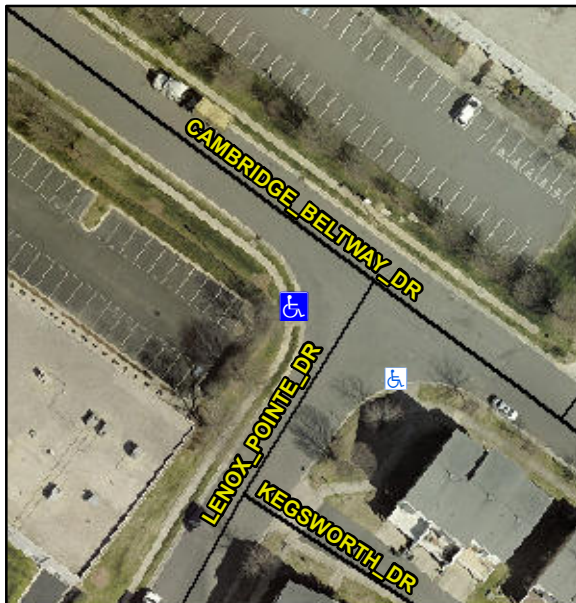
Compliance	Description	Data	Compliance	Description	Data
N/A	Ramp Length (in)	97.0	Yes	Ramp Slope (%)	7.9
No	Ramp Width (in)	44.5	Yes	Ramp XSlope (%)	0.8
N/A	Flare Type LT	N/A	N/A	Flare Type RT	N/A
N/A	Flare Slope LT (%)	N/A	N/A	Flare Slope RT (%)	N/A
N/A	Flare Traversable LT?	N/A	N/A	Flare Traversable RT?	N/A
N/A	Landing Length (in)	N/A	N/A	DWS Provided?	N/A
N/A	Landing Width (in)	N/A	N/A	DWS Contrast?	N/A
N/A	Landing Slope (%)	N/A	N/A	DWS Length (in)	N/A
N/A	Landing X Slope (%)	N/A	N/A	DWS Full Width?	N/A
N/A	Landing Curb? (Y/N)	N/A	N/A	DWS Offset (in)	N/A
N/A	Shared Landing?	N/A			
N/A	Gutter Ponding?	N/A	N/A	Gutter Slope (%)	N/A
N/A	Gutter Lip Ht (in)	N/A	N/A	Gutter X Slope (%)	N/A
N/A	Painted X Walk1?	No	N/A	Painted X Walk2?	No
	X Walk 1 Direction	To SE		X Walk 2 Direction	To NE
N/A	X Walk 1 Width (in)	N/A	N/A	X Walk 2 Width (in)	N/A
	X Walk 1 Slope (%)	0.3		X Walk 2 Slope (%)	1.2
	X Walk 1 X Slope (%)	0.4		X Walk 2 X Slope (%)	1.3

N/A	Ramp inside XWalk1?	N/A	N/A	Ramp inside XWalk2?	N/A
	Road Slope (%)	1.1	N/A	Clear Space?	N/A
	Road X Slope (%)	2.6	N/A	Clear Space to XWalk (in)	N/A
N/A	Any Obstructions?	N/A	N/A	Storm Grate/Utility Hazard?	N/A
	Obstruction Type			Storm Grate/Utility Type	
		N/A			N/A
			Yes	Surface Condition? (G/P)	Good

Remove & Replace Curb Ramp With Two New Directional Ramps or Equivalent.
