## **Access Compliance Report Public Rights-of-Way** (Curb Ramps)

Intersection ID: 28536 Main Street: SOUTH\_STREAM\_BV Cross Street: W\_TYVOLA\_RD Location: SE **Overall Compliance: No Severity Score:** ADA ID: A874D6372B62 Ramp Type: Perp Initial Pass/Fail: Fail 37.5

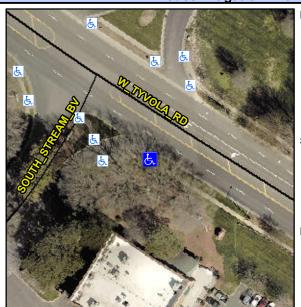
Field Measurements/Component Compliance								
Comp	liance Description	Data	Comp	liance	Description	Data		
N/A	Ramp Length (in)	33.0	No	Ramp	Slope (%)	11.0		
Yes	Ramp Width (in)	58.0	No	Ramp	XSlope (%)	7.9		
N/A	Flare Type LT	N/A	N/A	Flare	Type RT	N/A		
N/A	Flare Slope LT (%)	N/A	N/A	Flare	Slope RT (%)	N/A		
N/A	Flare Traversable LT?	N/A	N/A	Flare	Traversable RT?	N/A		
N/A	Landing Length (in)	N/A	N/A	DWS	Provided?	N/A		
N/A	Landing Width (in)	N/A	N/A	DWS	Contrast?	N/A		
N/A	Landing Slope (%)	N/A	N/A	DWS	Length (in)	N/A		
N/A	Landing X Slope (%)	N/A	N/A	DWS	Full Width?	N/A		
N/A	Landing Curb? (Y/N)	N/A	N/A	DWS	Offset (in)	N/A		
N/A	Shared Landing?	N/A						
N/A	Gutter Ponding?	N/A	N/A	Gutte	r Slope (%)	N/A		
N/A	Gutter Lip Ht (in)	N/A	N/A	Gutte	r X Slope (%)	N/A		
N/A	Painted X Walk1?	No	N/A	Paint	ed X Walk2?	N/A		
	X Walk 1 Direction	To N		X Wa	lk 2 Direction	N/A		
N/A	X Walk 1 Width (in)	N/A	N/A	X Wa	lk 2 Width (in)	N/A

X Walk 1 Slope (%)	2.7		X Wa	lk 2 Slope (%)	N/A		
	X Walk 1 X Slope (%)	3.6		X Wa	lk 2 X Slope (%)	N/A		
N/A	Ramp inside XWalk1?	N/A	N/A	Ramp	inside XWalk2?	N/A		
	Road Slope (%)	N/A	N/A	Clear	Space?	N/A		
	Road X Slope (%)	N/A	N/A	Clear	Space to XWalk (in)	N/A		
N/A	Any Obstructions?	N/A	N/A	Storm	n Grate/Utility Hazard?	N/A		
	Obstruction Type			Storm	n Grate/Utility Type			
		N/A				N/A		
			Yes	Surfa	ce Condition? (G/P)	Good

Possible Solutions:	9
Remove & Replace Entire Ramp.	ı
	١
	ı
	ľ
	ı
	1
Surveyor Notes:	ı
N/A	ı
Not Found, R304.2.2, R304.5.3	
	ľ
	_
	r
Surveyor Notes: N/A  PROW/ADA: Not Found, R304.2.2, R304.5.3	7 7 7 7 7 7
