# Access Compliance Report

## Public Rights-of-Way

### (Curb Ramps)

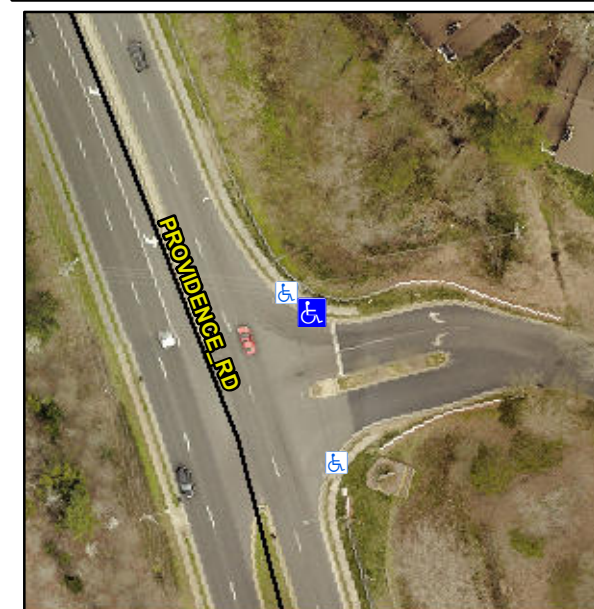
Intersection ID: N/A	Main Street: PROVIDENCE_RD	Cross Street: N/A	Location: NE
ADA ID: A87E98A0BB1D	Ramp Type: Perp	Initial Pass/Fail: Fail	Overall Compliance: No
Severity Score: 22.5			
Codes/Mitigation Info/Possible Solution		Field Measurements/Component Compliance

**Not Found, R304.5.1, R304.2.2, R304.5.3**

Compliance	Description	Data	Compliance	Description	Data
N/A	Ramp Length (in)	71.0	No	Ramp Slope (%)	8.5
No	Ramp Width (in)	36.0	No	Ramp XSlope (%)	4.3
N/A	Flare Type LT	N/A	N/A	Flare Type RT	N/A
N/A	Flare Slope LT (%)	N/A	N/A	Flare Slope RT (%)	N/A
N/A	Flare Traversable LT?	N/A	N/A	Flare Traversable RT?	N/A
N/A	Landing Length (in)	N/A	N/A	DWS Provided?	N/A
N/A	Landing Width (in)	N/A	N/A	DWS Contrast?	N/A
N/A	Landing Slope (%)	N/A	N/A	DWS Length (in)	N/A
N/A	Landing X Slope (%)	N/A	N/A	DWS Full Width?	N/A
N/A	Landing Curb? (Y/N)	N/A	N/A	DWS Offset (in)	N/A
N/A	Shared Landing?	N/A			
N/A	Gutter Ponding?	N/A	N/A	Gutter Slope (%)	N/A
N/A	Gutter Lip Ht (in)	N/A	N/A	Gutter X Slope (%)	N/A
N/A	Painted X Walk1?	No	N/A	Painted X Walk2?	N/A
	X Walk 1 Direction	To S		X Walk 2 Direction	N/A
N/A	X Walk 1 Width (in)	N/A	N/A	X Walk 2 Width (in)	N/A
	X Walk 1 Slope (%)	2.9		X Walk 2 Slope (%)	N/A
	X Walk 1 X Slope (%)	6.6		X Walk 2 X Slope (%)	N/A

**Remove & Replace Entire Ramp.**
