Access Compliance Report

Public Rights-of-Way

(Curb Ramps)

Intersection ID: N/A	Main Street: ELGIN_MOOR_RD	Cross Street: DOUGLAS_PALACE_CT	Location: NE
ADA ID: A888392A5867	Ramp Type: Perp	Initial Pass/Fail: Fail	Overall Compliance: No
			Severity Score: 13.75

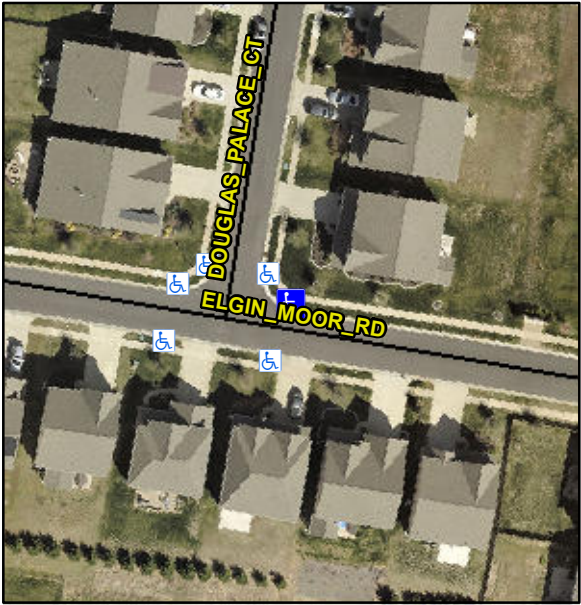
None				
	N/A				
	N/A				
<p>Total Cost:</p>	\$	1850.00			
<p>Compliance </p>	Description	Data	Compliance	Description	Data
No	Ramp Slope (%)	8.5			
No	Ramp XSlope (%)	3.4			
N/A	Flare Type RT	N/A			
N/A	Flare Slope RT (%)	N/A			
N/A	Flare Traversable RT?	N/A			
N/A	DWS Provided?	N/A			
N/A	DWS Contrast?	N/A			
N/A	DWS Length (in)	N/A			
N/A	DWS Full Width?	N/A			
N/A	DWS Offset (in)	N/A			
N/A	Gutter Slope (%)	N/A			
N/A	Gutter X Slope (%)	N/A			
N/A	Painted X Walk2?	N/A			
	X Walk 2 Direction	N/A			
N/A	X Walk 2 Width (in)	N/A			
	X Walk 2 Slope (%)	N/A			
	X Walk 2 X Slope (%)	N/A			
N/A	Ramp inside XWalk2?	N/A			
N/A	Clear Space?	N/A			
N/A	Clear Space to XWalk (in)	N/A			
N/A	Storm Grate/Utility Hazard?	N/A			
	Storm Grate/Utility Type				
N/A		N/A			
Yes	Surface Condition? (G/P)	Good

Possible Solutions:		Compliance	Description	Data
	Remove & Replace Entire Ramp.		N/A	Ramp Length (in)	50.0
			Yes	Ramp Width (in)	48.0
			N/A	Flare Type LT	N/A
			N/A	Flare Slope LT (%)	N/A
			N/A	Flare Traversable LT?	N/A
			N/A	Landing Length (in)	N/A
			N/A	Landing Width (in)	N/A
			N/A	Landing Slope (%)	N/A
			N/A	Landing X Slope (%)	N/A
<p>Surveyor Notes:</p> <p>N/A</p>			N/A	Landing Curb? (Y/N)	N/A
			N/A	Shared Landing?	N/A
			N/A	Gutter Ponding?	N/A
			N/A	Gutter Lip Ht (in)	1.0
			N/A	Painted X Walk1?	No
				X Walk 1 Direction	To SW
			N/A	X Walk 1 Width (in)	N/A
				X Walk 1 Slope (%)	0.8
				X Walk 1 X Slope (%)	1.2
			N/A	Ramp inside XWalk1?	N/A
<p>PROW/ADA:</p> <p>R304.2.2, R304.5.3</p>			N/A	Road Slope (%)	N/A
				Road X Slope (%)	N/A
			N/A	Any Obstructions?	N/A
				Obstruction Type	
<p>Street 1 Name</p> <p>Stop Condition-Street 2</p> <p>Street 2 Name</p> <p>Stop Condition-Street 1</p>	ELGIN MOOR RD
