# Access Compliance Report

## Public Rights-of-Way

### (Curb Ramps)

Intersection ID: 12605	Main Street: KENSINGTON_DR	Cross Street: THE_PLAZA	Location: NE
ADA ID: A8884F7FE2E1	Ramp Type: Directional1	Initial Pass/Fail: Fail	Overall Compliance: No
Severity Score: 26.25			
Codes/Mitigation Info/Possible Solution		Field Measurements/Component Compliance

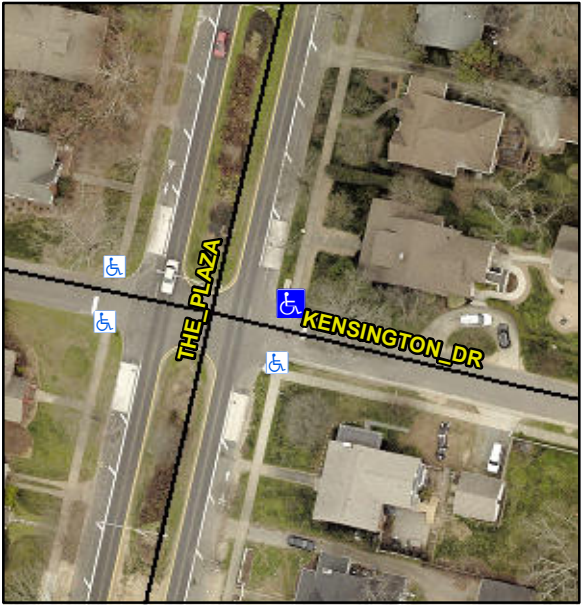
Compliance	Description	Data	Compliance	Description	Data
N/A	Ramp Length (in)	65.0	N/A	Grade Break?	N/A
Yes	Ramp Width (in)	65.0	N/A	Grade Break Slope (%)	0.0
No	Ramp Slope (%)	13.7	N/A	Grade Break XSlope (%)	0.0
No	Ramp XSlope (%)	2.8			
N/A	Flare Type LT	N/A	N/A	Flare Type RT	N/A
N/A	Flare Slope LT (%)	N/A	N/A	Flare Slope RT (%)	0.0
N/A	Flare Traversable LT?	N/A	N/A	Flare Traversable RT?	N/A
N/A	Landing Length (in)	0.0	N/A	DWS Provided?	N/A
N/A	Landing Width (in)	0.0	N/A	DWS Contrast?	N/A
N/A	Landing Slope (%)	0.0	N/A	DWS Length (in)	N/A
N/A	Landing X Slope (%)	0.0	N/A	DWS Full Width?	N/A
N/A	Landing Curb? (Y/N)	N/A	N/A	DWS Offset LT (in)	N/A
N/A	Shared Landing?	N/A	N/A	DWS Offset RT (in)	N/A
N/A	Gutter Ponding?	Yes	N/A	Gutter Slope (%)	N/A
N/A	Gutter Lip Ht (in)	0.0	N/A	Gutter X Slope (%)	N/A
N/A	Painted X Walk1?	No		Road Slope (%)	2.3
	X Walk 1 Direction	To S		Road X Slope (%)	4.8
	X Walk 1 Width (in)	N/A		Clear Space?	N/A

X Walk 1 Slope (%)	2.3	N/A	Clear Space to XWalk (in)	N/A
	X Walk 1 X Slope (%)	4.8	N/A	Storm Grate/Utility Hazard?	N/A
N/A	Ramp inside XWalk1?	N/A		Storm Grate/Utility Type	
N/A	Any Obstructions?	N/A			N/A
	Obstruction Type		Yes	Surface Condition? (G/P)	Good
			N/A	Curb Slope (%)	10.6

Possible Solutions:				
	Remove & Replace Entire Ramp.				
	Surveyor Notes:				
	N/A				
	PROW/ADA:				
	R304.2.2, R304.5.3				
	Street 1 Name	KENSINGTON DR			
	Stop Condition-Street 1	StopSign			
	Street 2 Name	N/A			
	Stop Condition-Street 2	N/A			
Total Cost:		\$	1600.00
