# Access Compliance Report

## Public Rights-of-Way

### (Curb Ramps)

Intersection ID: 11506	Main Street: GRACE_ST	Cross Street: UNION_ST	Location: NW
ADA ID: A8A8562212DB	Ramp Type: Perp	Initial Pass/Fail: Fail	Overall Compliance: No
Severity Score: 33.75			
Codes/Mitigation Info/Possible Solution		Field Measurements/Component Compliance

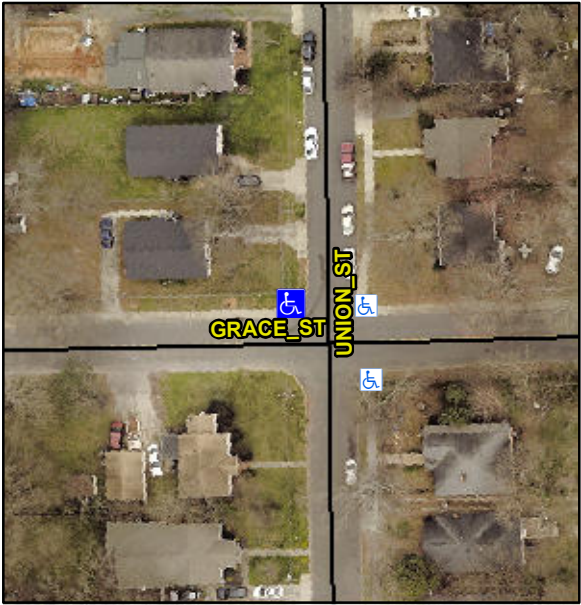
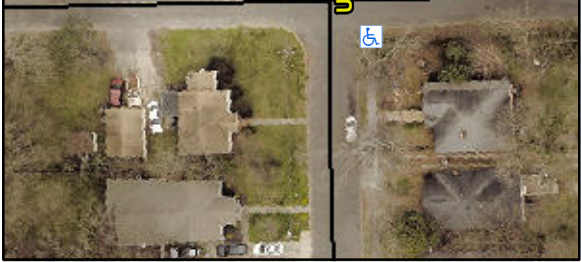
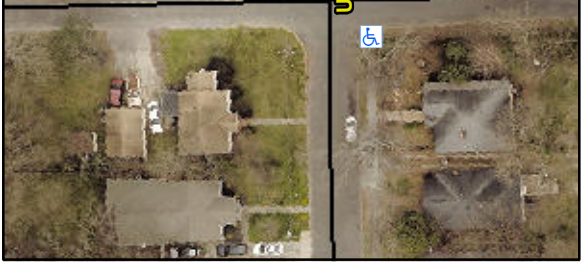
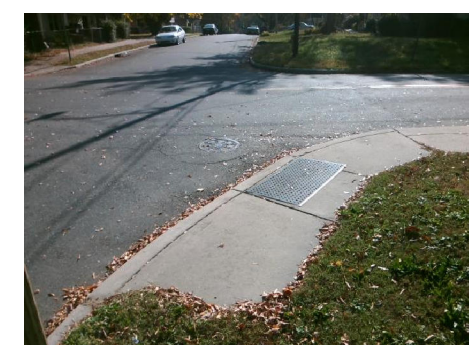
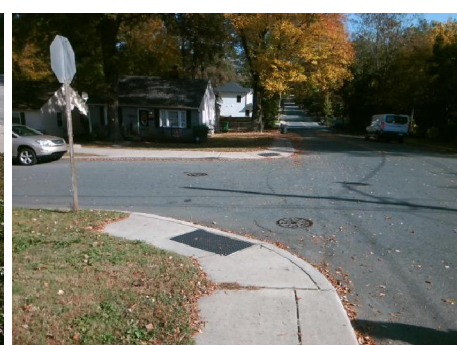
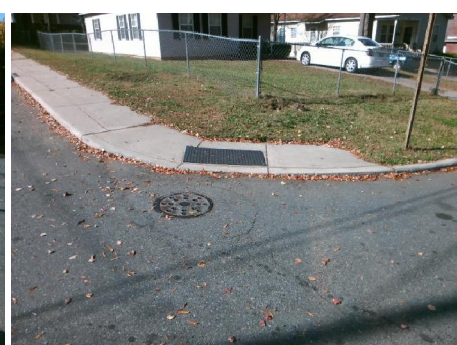
PROW/ADA:						
	Not Found, R304.5.1, R304.5.3						
Street 1 Name	UNION ST	Compliance	Description	Data	Compliance	Description	Data
Stop Condition-Street 2	StopSign	N/A	Ramp Length (in)	46.0	Yes	Ramp Slope (%)	5.3
Street 2 Name	N/A	No	Ramp Width (in)	41.0	No	Ramp XSlope (%)	8.6
Stop Condition-Street 1	N/A	N/A	Flare Type LT	N/A	N/A	Flare Type RT	N/A
		N/A	Flare Slope LT (%)	N/A	N/A	Flare Slope RT (%)	N/A
		N/A	Flare Traversable LT?	N/A	N/A	Flare Traversable RT?	N/A
		N/A	Landing Length (in)	N/A	N/A	DWS Provided?	N/A
		N/A	Landing Width (in)	N/A	N/A	DWS Contrast?	N/A
		N/A	Landing Slope (%)	N/A	N/A	DWS Length (in)	N/A
		N/A	Landing X Slope (%)	N/A	N/A	DWS Full Width?	N/A
		N/A	Landing Curb? (Y/N)	N/A	N/A	DWS Offset (in)	N/A
		N/A	Shared Landing?	N/A			
		N/A	Gutter Ponding?	N/A	N/A	Gutter Slope (%)	N/A

N/A	Gutter Lip Ht (in)	1.0	N/A	Gutter X Slope (%)	N/A
		N/A	Painted X Walk1?	No	N/A	Painted X Walk2?	N/A
			X Walk 1 Direction	To E		X Walk 2 Direction	N/A
		N/A	X Walk 1 Width (in)	N/A	N/A	X Walk 2 Width (in)	N/A
			X Walk 1 Slope (%)	4.1		X Walk 2 Slope (%)	N/A
			X Walk 1 X Slope (%)	8.6		X Walk 2 X Slope (%)	N/A
		N/A	Ramp inside XWalk1?	N/A	N/A	Ramp inside XWalk2?	N/A
			Road Slope (%)	N/A	N/A	Clear Space?	N/A
			Road X Slope (%)	N/A	N/A	Clear Space to XWalk (in)	N/A
		N/A	Any Obstructions?	N/A	N/A	Storm Grate/Utility Hazard?	N/A
			Obstruction Type			Storm Grate/Utility Type	
					N/A		N/A
					Yes	Surface Condition? (G/P)	Good
Total Cost:		\$ 1850.00

Possible Solutions:						
	Remove & Replace Entire Ramp.
