Access Compliance Report

Public Rights-of-Way

(Curb Ramps)

| Intersection ID: 27708 | Main Street: BREM_LN | Cross Street: LEDERER_AV | Location: NW |

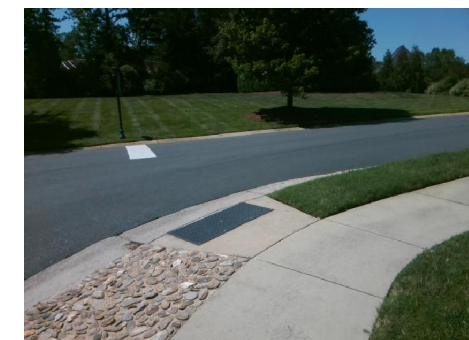
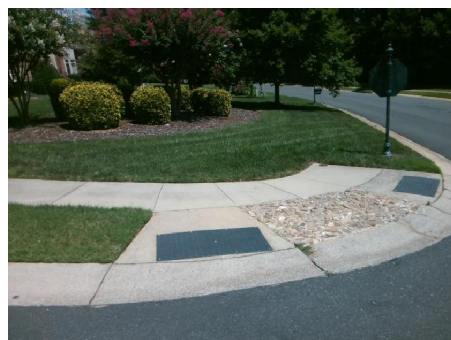
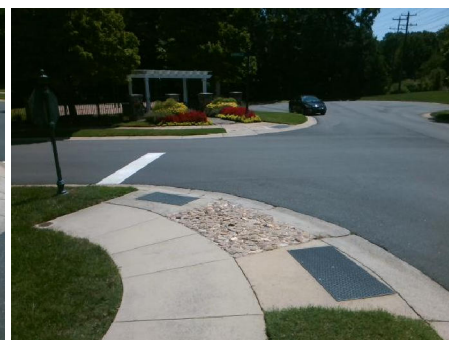
| ADA ID: A8CC7842F89C | Ramp Type: Perp | Initial Pass/Fail: Fail | Overall Compliance: No |

Not Found, R304.5.1, R304.5.3

| Compliance | Description | Data | Compliance | Description | Data |
|---|---|---|---|---|---|
| N/A | Ramp Length (in) | 52.0 | Yes | Ramp Slope (%) | 5.5 |
| No | Ramp Width (in) | 43.0 | No | Ramp XSlope (%) | 10.2 |

Remove & Replace Entire Ramp.

\$ 1850.00
