Access Compliance Report Public Rights-of-Way (Curb Ramps)

Intersection ID: 14734 Main Street: DILWORTH RD WEST **Cross Street: ISLEWORTH AV** Location: **Overall Compliance: No** ADA ID: A8CF13D66549 Ramp Type: BlendTrans1 Initial Pass/Fail: Fail **Severity Score:** 1.25

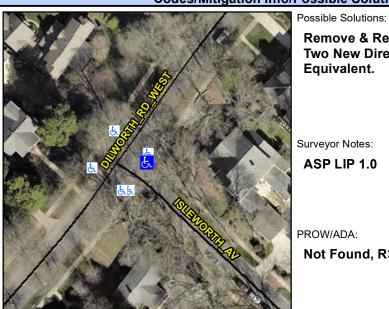
ASP LIP 1.0

Not Found, R304.5.3

Field Measure	ements/C	ompo	nent Compliance	
	Compliance Description		Data	Compliance Description		Data
	N/A	Ramp Length (in)	24.0	Yes	BlendTrans Slope (%)	1.5
	Yes	Ramp Width (in)	48.0	No	BlendTrans XSlope (%)	3.8
	N/A	Flare Type LT	N/A	N/A	Flare Type RT	N/A
	N/A	Flare Slope LT (%)	N/A	N/A	Flare Slope RT (%)	N/A
	N/A	Flare Traversable LT?	N/A	N/A	Flare Traversable RT?	N/A
	N/A	Landing Length (in)	N/A	N/A	DWS Provided?	N/A
	N/A	Landing Width (in)	N/A	N/A	DWS Contrast?	N/A
	N/A	Landing Slope (%)	N/A	N/A	DWS Length (in)	N/A
	N/A	Landing X Slope (%)	N/A	N/A	DWS Full Width?	N/A
	N/A	Landing Curb? (Y/N)	N/A	N/A	DWS Offset (in)	N/A
	N/A	Shared Landing?	N/A			
	N/A	Gutter Ponding?	N/A	N/A	Gutter Slope (%)	N/A
	N/A	Gutter Lip Ht (in)	N/A	N/A	Gutter X Slope (%)	N/A
	N/A	Painted X Walk1?	No	N/A	Painted X Walk2?	N/A
		X Walk 1 Direction	To SW		X Walk 2 Direction	N/A
		X Walk 1 Width (in)	N/A		X Walk 2 Width (in)	N/A

X Walk 1 Slope (%)	8.2		X Walk 2 Slope (%)	N/A
		X Walk 1 X Slope (%)	0.8		X Walk 2 X Slope (%)	N/A
	N/A	Ramp inside XWalk1?	N/A	N/A	Ramp inside XWalk2?	N/A
		Road Slope (%)	0.8		Clear Space?	N/A
		Road X Slope (%)	8.2	N/A	Clear Space to XWalk (in)	N/A
	N/A	Any Obstructions?	N/A	N/A	Storm Grate/Utility Hazard?	N/A
		Obstruction Type			Storm Grate/Utility Type	
			N/A			N/A
				Yes	Surface Condition? (G/P)	Good
				No	Curb Slope (%)	10.2

ISLEWORTH AV Street 1 Name Stop Condition-Street 1 StopSign Street 2 Name N/A Stop Condition-Street 2 N/A Remove & Replace Curb Ramp With Two New Directional Ramps or Equivalent.
