# Access Compliance Report

## Public Rights-of-Way

### (Curb Ramps)

Intersection ID: 27763	Main Street: BALLANTYNE_CROSSING_AV	Cross Street: BRICK_CHURCH_CT	Location: W
ADA ID: A8CFC93E13B1	Ramp Type: BlendTrans1	Initial Pass/Fail: Fail	Overall Compliance: No
Severity Score: 21.25			
Codes/Mitigation Info/Possible Solution		Field Measurements/Component Compliance

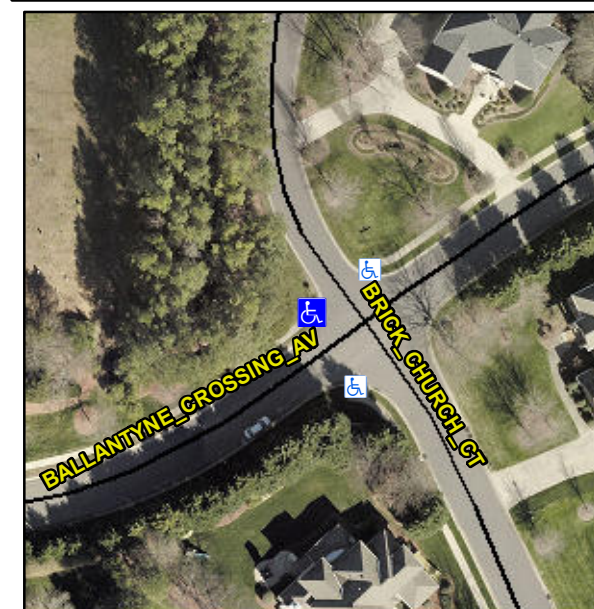
**R304.5.1, R304.5.3**

Compliance	Description	Data	Compliance	Description	Data
N/A	Ramp Length (in)	50.0	Yes	BlendTrans Slope (%)	4.3
No	Ramp Width (in)	46.0	No	BlendTrans XSlope (%)	5.5
N/A	Flare Type LT	N/A	N/A	Flare Type RT	N/A
N/A	Flare Slope LT (%)	N/A	N/A	Flare Slope RT (%)	N/A
N/A	Flare Traversable LT?	N/A	N/A	Flare Traversable RT?	N/A
N/A	Landing Length (in)	N/A	N/A	DWS Provided?	N/A
N/A	Landing Width (in)	N/A	N/A	DWS Contrast?	N/A
N/A	Landing Slope (%)	N/A	N/A	DWS Length (in)	N/A
N/A	Landing X Slope (%)	N/A	N/A	DWS Full Width?	N/A
N/A	Landing Curb? (Y/N)	N/A	N/A	DWS Offset (in)	N/A
N/A	Shared Landing?	N/A			
N/A	Gutter Ponding?	N/A	N/A	Gutter Slope (%)	N/A
N/A	Gutter Lip Ht (in)	N/A	N/A	Gutter X Slope (%)	N/A
N/A	Painted X Walk1?	No	N/A	Painted X Walk2?	No
	X Walk 1 Direction	To SE		X Walk 2 Direction	To NE
	X Walk 1 Width (in)	N/A		X Walk 2 Width (in)	N/A
	X Walk 1 Slope (%)	8.5		X Walk 2 Slope (%)	1.1
	X Walk 1 X Slope (%)	0.3		X Walk 2 X Slope (%)	5.4

N/A	Ramp inside XWalk1?	N/A	N/A	Ramp inside XWalk2?	N/A
	Road Slope (%)	5.5		Clear Space?	N/A
	Road X Slope (%)	4.0	N/A	Clear Space to XWalk (in)	N/A
N/A	Any Obstructions?	N/A	N/A	Storm Grate/Utility Hazard?	N/A
	Obstruction Type			Storm Grate/Utility Type	
		N/A			N/A
			Yes	Surface Condition? (G/P)	Good
			N/A	Curb Slope (%)	4.1

**Remove & Replace Curb Ramp With Two New Directional Ramps or Equivalent.**
