Intersection ID: 5595	Main Street: CORNELIA_DR	Cross Street: STARMOUNT_AV	Location:	W
ADA ID: A8D157E276F0	Ramp Type: Perp	Initial Pass/Fail: Fail	Overall Compliance: No	Severity Score: 43.75

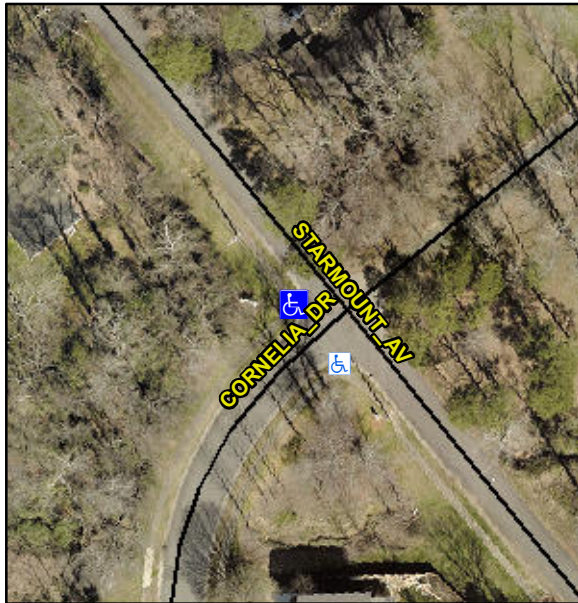
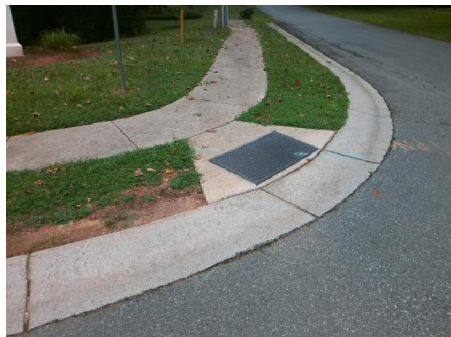
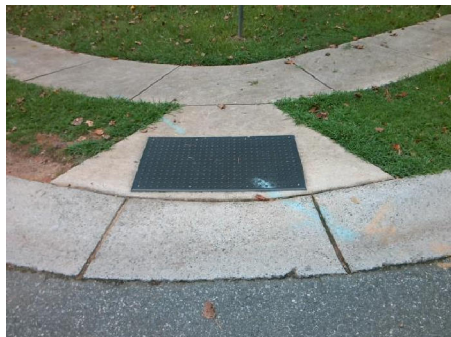
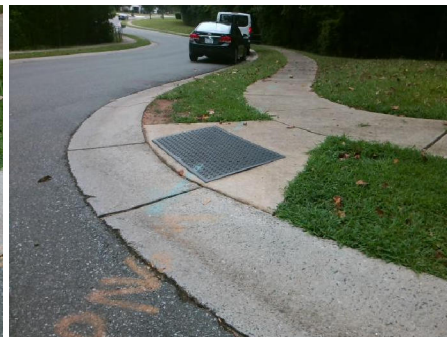
**Not Found, R304.5.1, R304.2.2,
R304.5.3**

Possible Solutions:			Compliance	Description	Data	Compliance	Description	Data
Remove & Replace Entire Ramp.			N/A	Ramp Length (in)	50.0	No	Ramp Slope (%)	12.2
			No	Ramp Width (in)	35.0	No	Ramp XSlope (%)	2.8
			N/A	Flare Type LT	N/A	N/A	Flare Type RT	N/A
			N/A	Flare Slope LT (%)	N/A	N/A	Flare Slope RT (%)	N/A
			N/A	Flare Traversable LT?	N/A	N/A	Flare Traversable RT?	N/A
			N/A	Landing Length (in)	N/A	N/A	DWS Provided?	N/A
			N/A	Landing Width (in)	N/A	N/A	DWS Contrast?	N/A
			N/A	Landing Slope (%)	N/A	N/A	DWS Length (in)	N/A
			N/A	Landing X Slope (%)	N/A	N/A	DWS Full Width?	N/A
			N/A	Landing Curb? (Y/N)	N/A	N/A	DWS Offset (in)	N/A
Surveyor Notes:			N/A	Shared Landing?	N/A			
PROW/ADA:			N/A	Gutter Ponding?	N/A	N/A	Gutter Slope (%)	N/A
Not Found, R304.5.1, R304.2.2, R304.5.3			N/A	Gutter Lip Ht (in)	0.5	N/A	Gutter X Slope (%)	N/A
			N/A	Painted X Walk1?	No	N/A	Painted X Walk2?	N/A
				X Walk 1 Direction	To S		X Walk 2 Direction	N/A

N/A	X Walk 1 Width (in)	N/A	N/A	X Walk 2 Width (in)	N/A
				X Walk 1 Slope (%)	4.0		X Walk 2 Slope (%)	N/A
				X Walk 1 X Slope (%)	0.7		X Walk 2 X Slope (%)	N/A
			N/A	Ramp inside XWalk1?	N/A	N/A	Ramp inside XWalk2?	N/A
				Road Slope (%)	N/A	N/A	Clear Space?	N/A
				Road X Slope (%)	N/A	N/A	Clear Space to XWalk (in)	N/A
			N/A	Any Obstructions?	N/A	N/A	Storm Grate/Utility Hazard?	N/A
Total Cost:	\$	1850.00		Obstruction Type			Storm Grate/Utility Type	
					N/A			N/A
						Yes	Surface Condition? (G/P)	Good

Remove & Replace Entire Ramp.
