Access Compliance Report

Public Rights-of-Way

(Curb Ramps)

Intersection ID: 29416	Main Street: PADDARBORN_CT	Cross Street: SALINGER_WY	Location: NW
ADA ID: A8D4684A1EA8	Ramp Type: Perp	Initial Pass/Fail: Fail	Overall Compliance: No
Severity Score: 12.5			
Codes/Mitigation Info/Possible Solution		Field Measurements/Component Compliance

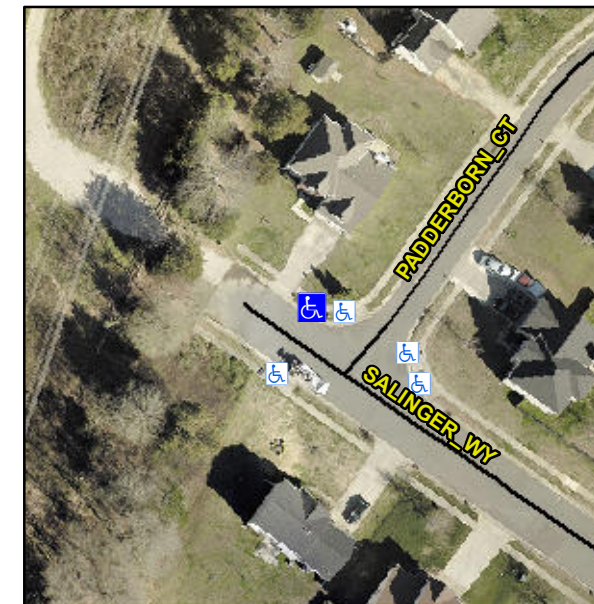
Not Found, R304.2.2

Compliance	Description	Data	Compliance	Description	Data
N/A	Ramp Length (in)	49.0	No	Ramp Slope (%)	11.6
Yes	Ramp Width (in)	48.0	Yes	Ramp XSlope (%)	1.1
N/A	Flare Type LT	N/A	N/A	Flare Type RT	N/A
N/A	Flare Slope LT (%)	N/A	N/A	Flare Slope RT (%)	N/A
N/A	Flare Traversable LT?	N/A	N/A	Flare Traversable RT?	N/A
N/A	Landing Length (in)	N/A	N/A	DWS Provided?	N/A
N/A	Landing Width (in)	N/A	N/A	DWS Contrast?	N/A
N/A	Landing Slope (%)	N/A	N/A	DWS Length (in)	N/A
N/A	Landing X Slope (%)	N/A	N/A	DWS Full Width?	N/A
N/A	Landing Curb? (Y/N)	N/A	N/A	DWS Offset (in)	N/A
N/A	Shared Landing?	N/A			
N/A	Gutter Ponding?	N/A	N/A	Gutter Slope (%)	N/A
N/A	Gutter Lip Ht (in)	N/A	N/A	Gutter X Slope (%)	N/A
N/A	Painted X Walk1?	No	N/A	Painted X Walk2?	N/A
	X Walk 1 Direction	To SW		X Walk 2 Direction	N/A
N/A	X Walk 1 Width (in)	N/A	N/A	X Walk 2 Width (in)	N/A
	X Walk 1 Slope (%)	3.8		X Walk 2 Slope (%)	N/A
	X Walk 1 X Slope (%)	2.1		X Walk 2 X Slope (%)	N/A

N/A	Ramp inside XWalk1?	N/A	N/A	Ramp inside XWalk2?	N/A
	Road Slope (%)	N/A	N/A	Clear Space?	N/A
	Road X Slope (%)	N/A	N/A	Clear Space to XWalk (in)	N/A
N/A	Any Obstructions?	N/A	N/A	Storm Grate/Utility Hazard?	N/A
	Obstruction Type			Storm Grate/Utility Type	
		N/A			N/A
			Yes	Surface Condition? (G/P)	Good

Remove & Replace Entire Ramp.

Total Cost: \$ 1850.00
