## Access Compliance Report Public Rights-of-Way (Curb Ramps)

Intersection ID: 10028640Main Street: HORACE\_STCross Street: N/ALocation:NEADA ID: A8D62E51A6F5Ramp Type: PerpInitial Pass/Fail: FailOverall Compliance: NoSeverity Score: 12.5

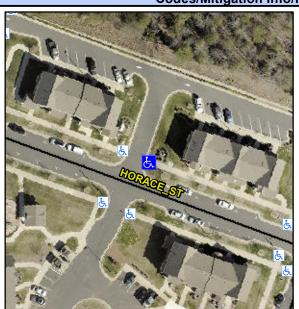
Compi	liance Description	Data	Comp	oliance Description	Data
N/A	Ramp Length (in)	71.0	No	Ramp Slope (%)	8.7
Yes	Ramp Width (in)	71.5	Yes	Ramp XSlope (%)	0.3
N/A	Flare Type LT	N/A	N/A	Flare Type RT	N/A
N/A	Flare Slope LT (%)	N/A	N/A	Flare Slope RT (%)	N/A
N/A	Flare Traversable LT?	N/A	N/A	Flare Traversable RT?	N/A
N/A	Landing Length (in)	N/A	N/A	DWS Provided?	N/A
N/A	Landing Width (in)	N/A	N/A	DWS Contrast?	N/A
N/A	Landing Slope (%)	N/A	N/A	DWS Length (in)	N/A
N/A	Landing X Slope (%)	N/A	N/A	DWS Full Width?	N/A
N/A	Landing Curb? (Y/N)	N/A	N/A	DWS Offset (in)	N/A
N/A	Shared Landing?	N/A			
N/A	Gutter Ponding?	N/A	N/A	Gutter Slope (%)	N/A
N/A	Gutter Lip Ht (in)	N/A	N/A	Gutter X Slope (%)	N/A
N/A	Painted X Walk1?	No	N/A	Painted X Walk2?	N/A
	X Walk 1 Direction	To NW		X Walk 2 Direction	N/A
N/A	X Walk 1 Width (in)	N/A	N/A	X Walk 2 Width (in)	N/A
	X Walk 1 Slope (%)	4.7		X Walk 2 Slope (%)	N/A
	X Walk 1 X Slope (%)	2.1		X Walk 2 X Slope (%)	N/A

N/A	Ramp inside XWalk1?	N/A	N/A	Ramp inside XWalk2?	N/A
	Road Slope (%)	N/A	N/A	Clear Space?	N/A
	Road X Slope (%)	N/A	N/A	Clear Space to XWalk (in)	N/A
N/A	Any Obstructions?	N/A	N/A	Storm Grate/Utility Hazard?	N/A
	Obstruction Type			Storm Grate/Utility Type	
		N/A			N/A
			Yes	Surface Condition? (G/P)	Good

Possible Solutions:	Comp
Remove & Replace Entire Ramp.	N/A
·	Yes
	N/A
	N/A
	N/A
	N/A
Surveyor Notes:	N/A
N/A	N/A
	N/A
	N/A
	N/A
PROW/ADA:	N/A
R304.2.2	N/A
	N/A
	N/A
	N/A
