# Access Compliance Report

## Public Rights-of-Way

### (Curb Ramps)

Intersection ID: 11841	Main Street: E_18TH_ST	Cross Street: HARRILL_ST	Location: S
ADA ID: A8DF5248EE3A	Ramp Type: PerpDiag	Initial Pass/Fail: Fail	Overall Compliance: No
		Severity Score: 35

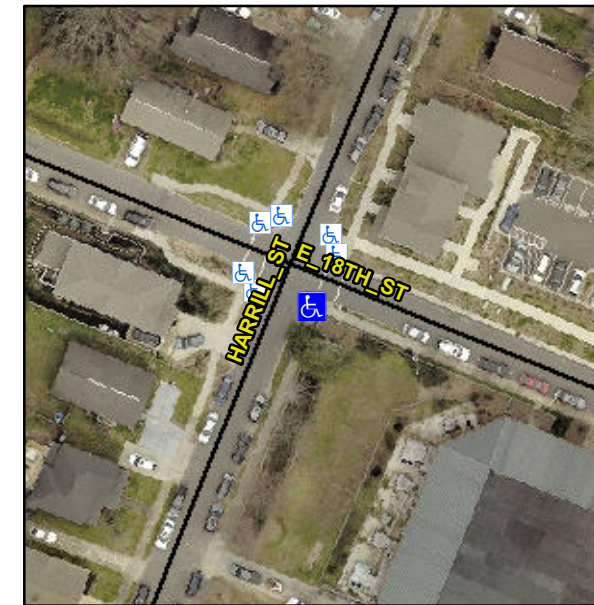
**Not Found, R304.5.1**

Compliance	Description	Data	Compliance	Description	Data
N/A	Ramp Length (in)	74.0	Yes	Ramp Slope (%)	6.3
No	Ramp Width (in)	24.0	Yes	Ramp XSlope (%)	0.9
N/A	Flare Type LT	N/A	N/A	Flare Type RT	N/A
N/A	Flare Slope LT (%)	N/A	N/A	Flare Slope RT (%)	N/A
N/A	Flare Traversable LT?	N/A	N/A	Flare Traversable RT?	N/A
N/A	Landing Length (in)	N/A	N/A	DWS Provided?	N/A
N/A	Landing Width (in)	N/A	N/A	DWS Contrast?	N/A
N/A	Landing Slope (%)	N/A	N/A	DWS Length (in)	N/A
N/A	Landing X Slope (%)	N/A	N/A	DWS Full Width?	N/A
N/A	Landing Curb? (Y/N)	N/A	N/A	DWS Offset (in)	N/A
N/A	Shared Landing?	N/A			
N/A	Gutter Ponding?	N/A	N/A	Gutter Slope (%)	N/A
N/A	Gutter Lip Ht (in)	N/A	N/A	Gutter X Slope (%)	N/A
N/A	Painted X Walk1?	No	N/A	Painted X Walk2?	No
	X Walk 1 Direction	To NE		X Walk 2 Direction	To NW
N/A	X Walk 1 Width (in)	N/A	N/A	X Walk 2 Width (in)	N/A
	X Walk 1 Slope (%)	4.8		X Walk 2 Slope (%)	2.1
	X Walk 1 X Slope (%)	0.4		X Walk 2 X Slope (%)	2.4

N/A	Ramp inside XWalk1?	N/A	N/A	Ramp inside XWalk2?	N/A
	Road Slope (%)	2.8	N/A	Clear Space?	N/A
	Road X Slope (%)	4.1	N/A	Clear Space to XWalk (in)	N/A
N/A	Any Obstructions?	N/A	N/A	Storm Grate/Utility Hazard?	N/A
	Obstruction Type			Storm Grate/Utility Type	
		N/A			N/A
			Yes	Surface Condition? (G/P)	Good

**Remove & Replace Curb Ramp With Two New Directional Ramps or Equivalent.**

Total Cost: \$ 3200.00
