# Access Compliance Report

## Public Rights-of-Way

### (Curb Ramps)

| Intersection ID: 47454 | Main Street: WOOD_DUCK_CROSSING_DR | Cross Street: WINGED_TEAL_RD | Location: SW |

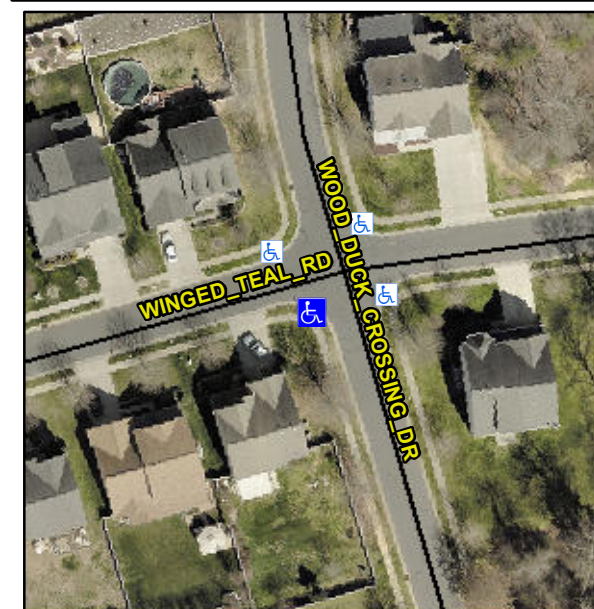
| ADA ID: A8E1C6A036E9 | Ramp Type: PerpDiag | Initial Pass/Fail: Pass | Overall Compliance: No |
| Severity Score: 0.25 | | | |

**R304.5.3, R304.2.1, R305.2**

| Compliance | Description | Data | Compliance | Description | Data |
|---|---|---|---|---|---|
| Yes | Ramp Width (in) | 48.0 | No | Ramp XSlope (%) | 2.4 |
| No | Landing Length (in) | 47.0 | Yes | DWS Provided? | Yes |
| No | Landing X Slope (%) | 4.9 | Yes | DWS Full Width? | Yes |
| Yes | Gutter Lip Ht (in) | 0.0 | No | Gutter X Slope (%) | 2.7 |

**Remove & Replace Curb Ramp With Two New Directional Ramps or Equivalent. Remove & Replace Gutter.**

Total Cost: \$ 3950.00
