Access Compliance Report

Public Rights-of-Way

(Curb Ramps)

Intersection ID: 27777	Main Street: BRIARWICK_LN	Cross Street: MOSS_MILL_LN	Location: SE
ADA ID: A8E913D47E9B	Ramp Type: PerpDiag	Initial Pass/Fail: Fail	Overall Compliance: No
Severity Score: 12.5			
Codes/Mitigation Info/Possible Solution		Field Measurements/Component Compliance

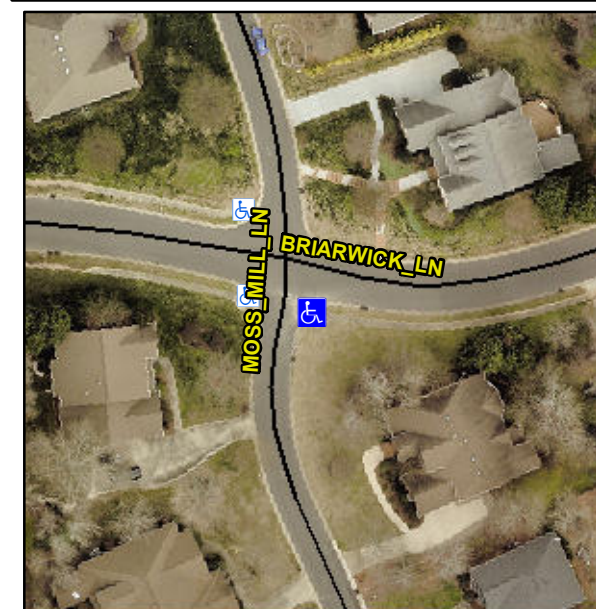
Compliance	Description	Data	Compliance	Description	Data
N/A	Ramp Length (in)	98.0	No	Ramp Slope (%)	8.5
Yes	Ramp Width (in)	48.0	Yes	Ramp XSlope (%)	1.8
N/A	Flare Type LT	N/A	N/A	Flare Type RT	N/A
N/A	Flare Slope LT (%)	N/A	N/A	Flare Slope RT (%)	N/A
N/A	Flare Traversable LT?	N/A	N/A	Flare Traversable RT?	N/A
N/A	Landing Length (in)	N/A	N/A	DWS Provided?	N/A
N/A	Landing Width (in)	N/A	N/A	DWS Contrast?	N/A
N/A	Landing Slope (%)	N/A	N/A	DWS Length (in)	N/A
N/A	Landing X Slope (%)	N/A	N/A	DWS Full Width?	N/A
N/A	Landing Curb? (Y/N)	N/A	N/A	DWS Offset (in)	N/A
N/A	Shared Landing?	N/A			
N/A	Gutter Ponding?	N/A	N/A	Gutter Slope (%)	N/A
N/A	Gutter Lip Ht (in)	N/A	N/A	Gutter X Slope (%)	N/A
N/A	Painted X Walk1?	No	N/A	Painted X Walk2?	No
	X Walk 1 Direction	To NE		X Walk 2 Direction	To NW
N/A	X Walk 1 Width (in)	N/A	N/A	X Walk 2 Width (in)	N/A
	X Walk 1 Slope (%)	4.5		X Walk 2 Slope (%)	0.6
	X Walk 1 X Slope (%)	2.8		X Walk 2 X Slope (%)	1.3

N/A	Ramp inside XWalk1?	N/A	N/A	Ramp inside XWalk2?	N/A
	Road Slope (%)	2.0	N/A	Clear Space?	N/A
	Road X Slope (%)	1.4	N/A	Clear Space to XWalk (in)	N/A
N/A	Any Obstructions?	N/A	N/A	Storm Grate/Utility Hazard?	N/A
	Obstruction Type			Storm Grate/Utility Type	
		N/A			N/A
		Yes		Surface Condition? (G/P)	Good

Possible Solutions:

Remove & Replace Curb Ramp With Two New Directional Ramps or Equivalent.

R304.2.2
