# Access Compliance Report

## Public Rights-of-Way

### (Curb Ramps)

Intersection ID: 2857	Main Street: BEAUVISTA_DR	Cross Street: BEECH_COVE_LN	Location: NE
ADA ID: A8E994321982	Ramp Type: PerpDiag	Initial Pass/Fail: Fail	Overall Compliance: No
Severity Score: 33.75			
Codes/Mitigation Info/Possible Solution		Field Measurements/Component Compliance

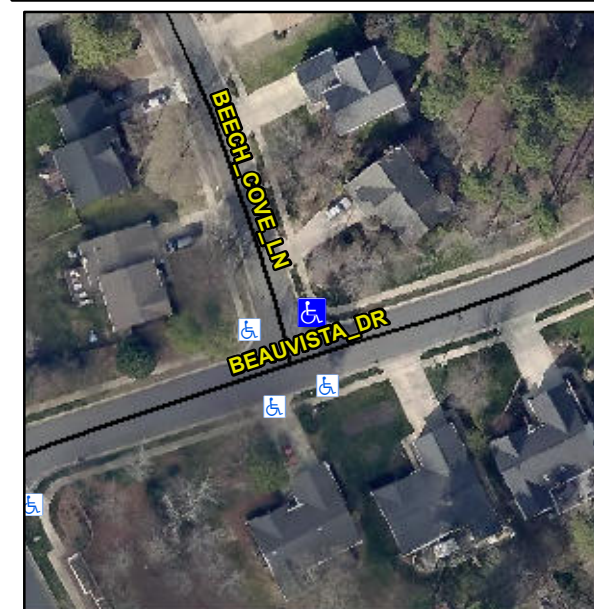
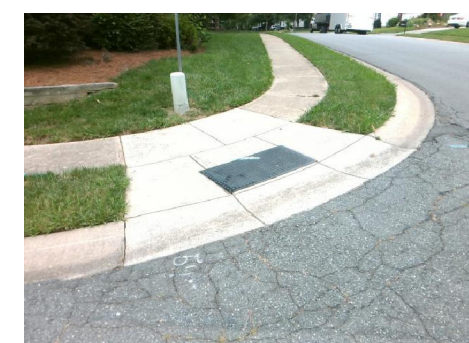
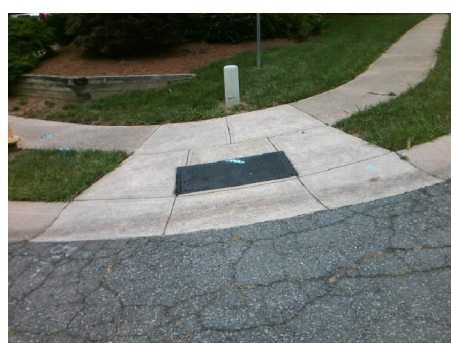
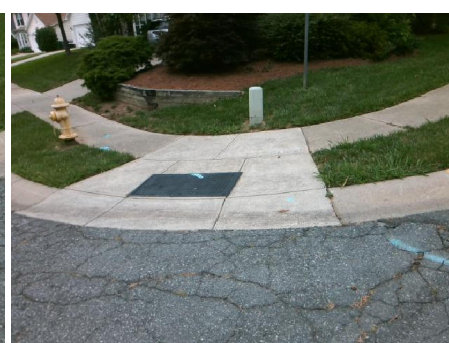
**Not Found, R304.5.1, R304.5.3**

Compliance	Description	Data	Compliance	Description	Data
N/A	Ramp Length (in)	46.0	Yes	Ramp Slope (%)	5.8
No	Ramp Width (in)	39.0	No	Ramp XSlope (%)	10.6
N/A	Flare Type LT	N/A	N/A	Flare Type RT	N/A
N/A	Flare Slope LT (%)	N/A	N/A	Flare Slope RT (%)	N/A
N/A	Flare Traversable LT?	N/A	N/A	Flare Traversable RT?	N/A
N/A	Landing Length (in)	N/A	N/A	DWS Provided?	N/A
N/A	Landing Width (in)	N/A	N/A	DWS Contrast?	N/A
N/A	Landing Slope (%)	N/A	N/A	DWS Length (in)	N/A
N/A	Landing X Slope (%)	N/A	N/A	DWS Full Width?	N/A
N/A	Landing Curb? (Y/N)	N/A	N/A	DWS Offset (in)	N/A
N/A	Shared Landing?	N/A			
N/A	Gutter Ponding?	N/A	N/A	Gutter Slope (%)	N/A
N/A	Gutter Lip Ht (in)	N/A	N/A	Gutter X Slope (%)	N/A
N/A	Painted X Walk1?	No	N/A	Painted X Walk2?	No
	X Walk 1 Direction	To W		X Walk 2 Direction	To S
N/A	X Walk 1 Width (in)	N/A	N/A	X Walk 2 Width (in)	N/A
	X Walk 1 Slope (%)	2.3		X Walk 2 Slope (%)	9.0
	X Walk 1 X Slope (%)	4.3		X Walk 2 X Slope (%)	6.4

N/A	Ramp inside XWalk1?	N/A	N/A	Ramp inside XWalk2?	N/A
	Road Slope (%)	6.0	N/A	Clear Space?	N/A
	Road X Slope (%)	1.4	N/A	Clear Space to XWalk (in)	N/A
N/A	Any Obstructions?	N/A	N/A	Storm Grate/Utility Hazard?	N/A
	Obstruction Type			Storm Grate/Utility Type	
		N/A			N/A
		Yes		Surface Condition? (G/P)	Good

**Remove & Replace Curb Ramp With Two New Directional Ramps or Equivalent.**

Total Cost: \$ 3200.00
