Access Compliance Report

Public Rights-of-Way

(Curb Ramps)

Intersection ID: 16905	Main Street: BILTMORE_DR	Cross Street: SCOTLAND_AV	Location: NW
ADA ID: A90611C9C60A	Ramp Type: Perp	Initial Pass/Fail: Fail	Overall Compliance: No
		Severity Score: 25

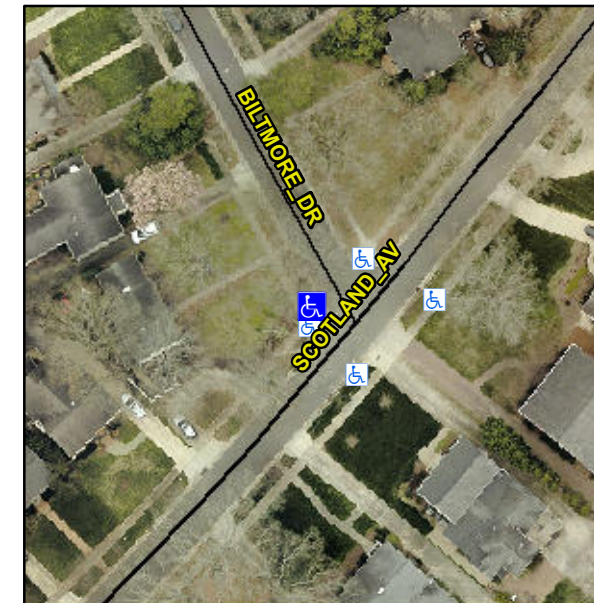
Not Found, R304.2.2, R304.5.3

Compliance	Description	Data	Compliance	Description	Data
N/A	Ramp Length (in)	75.0	No	Ramp Slope (%)	11.3
Yes	Ramp Width (in)	51.5	No	Ramp XSlope (%)	6.2
N/A	Flare Type LT	N/A	N/A	Flare Type RT	N/A
N/A	Flare Slope LT (%)	N/A	N/A	Flare Slope RT (%)	N/A
N/A	Flare Traversable LT?	N/A	N/A	Flare Traversable RT?	N/A
N/A	Landing Length (in)	N/A	N/A	DWS Provided?	N/A
N/A	Landing Width (in)	N/A	N/A	DWS Contrast?	N/A
N/A	Landing Slope (%)	N/A	N/A	DWS Length (in)	N/A
N/A	Landing X Slope (%)	N/A	N/A	DWS Full Width?	N/A
N/A	Landing Curb? (Y/N)	N/A	N/A	DWS Offset (in)	N/A
N/A	Shared Landing?	N/A			
N/A	Gutter Ponding?	N/A	N/A	Gutter Slope (%)	N/A
N/A	Gutter Lip Ht (in)	N/A	N/A	Gutter X Slope (%)	N/A
N/A	Painted X Walk1?	No	N/A	Painted X Walk2?	N/A
	X Walk 1 Direction	To NE		X Walk 2 Direction	N/A
N/A	X Walk 1 Width (in)	N/A	N/A	X Walk 2 Width (in)	N/A
	X Walk 1 Slope (%)	0.9		X Walk 2 Slope (%)	N/A
	X Walk 1 X Slope (%)	1.8		X Walk 2 X Slope (%)	N/A

N/A	Ramp inside XWalk1?	N/A	N/A	Ramp inside XWalk2?	N/A
	Road Slope (%)	N/A	N/A	Clear Space?	N/A
	Road X Slope (%)	N/A	N/A	Clear Space to XWalk (in)	N/A
N/A	Any Obstructions?	N/A	N/A	Storm Grate/Utility Hazard?	N/A
	Obstruction Type			Storm Grate/Utility Type	
		N/A			N/A
			Yes	Surface Condition? (G/P)	Good

Remove & Replace Entire Ramp.
