Access Compliance Report

Public Rights-of-Way

(Curb Ramps)

Intersection ID: N/A	Main Street: S_MCDOWELL_ST	Cross Street: E_STONEWALL_ST	Location: NE
ADA ID: A9133DF8FAAE	Ramp Type: Perp	Initial Pass/Fail: Fail	Overall Compliance: No
		Severity Score: 8.75	
Codes/Mitigation Info/Possible Solution		Field Measurements/Component Compliance

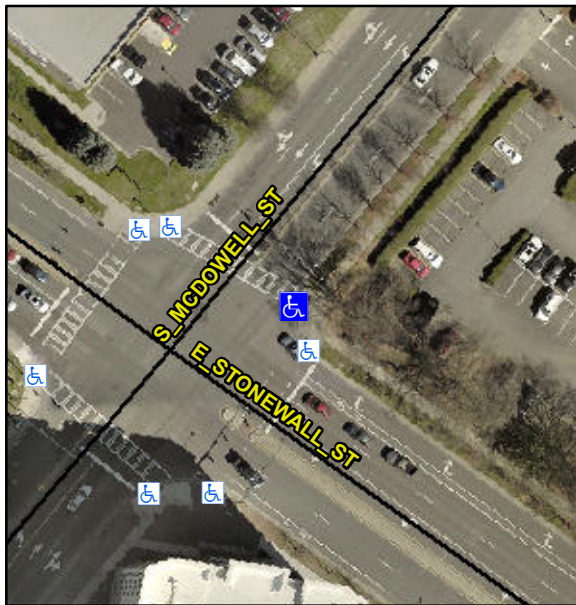
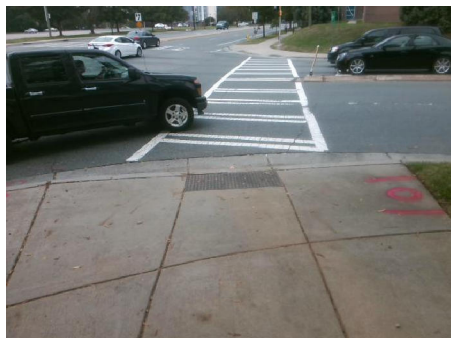
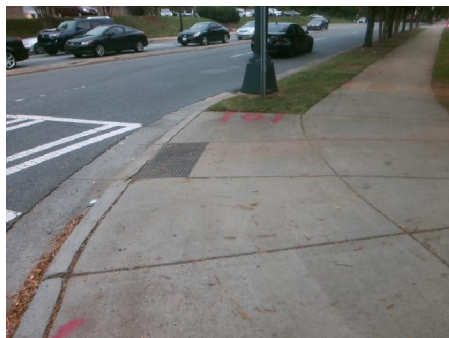
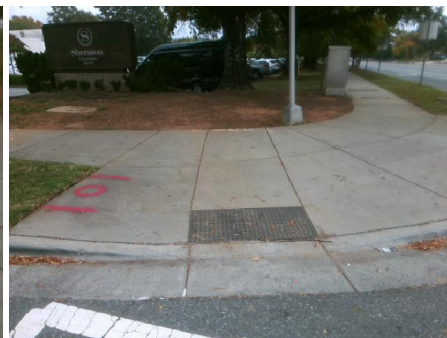
Not Found, R304.5.1

Compliance	Description	Data	Compliance	Description	Data
N/A	Ramp Length (in)	83.0	Yes	Ramp Slope (%)	7.2
No	Ramp Width (in)	46.0	Yes	Ramp XSlope (%)	1.9
N/A	Flare Type LT	N/A	N/A	Flare Type RT	N/A
N/A	Flare Slope LT (%)	N/A	N/A	Flare Slope RT (%)	N/A
N/A	Flare Traversable LT?	N/A	N/A	Flare Traversable RT?	N/A
N/A	Landing Length (in)	N/A	N/A	DWS Provided?	N/A
N/A	Landing Width (in)	N/A	N/A	DWS Contrast?	N/A
N/A	Landing Slope (%)	N/A	N/A	DWS Length (in)	N/A
N/A	Landing X Slope (%)	N/A	N/A	DWS Full Width?	N/A
N/A	Landing Curb? (Y/N)	N/A	N/A	DWS Offset (in)	N/A
N/A	Shared Landing?	N/A			
N/A	Gutter Ponding?	N/A	N/A	Gutter Slope (%)	N/A
N/A	Gutter Lip Ht (in)	N/A	N/A	Gutter X Slope (%)	N/A
N/A	Painted X Walk1?	Yes	N/A	Painted X Walk2?	N/A
	X Walk 1 Direction	To NW		X Walk 2 Direction	N/A
N/A	X Walk 1 Width (in)	110.0	N/A	X Walk 2 Width (in)	N/A
	X Walk 1 Slope (%)	2.5		X Walk 2 Slope (%)	N/A
	X Walk 1 X Slope (%)	2.8		X Walk 2 X Slope (%)	N/A

N/A	Ramp inside XWalk1?	Yes	N/A	Ramp inside XWalk2?	N/A
	Road Slope (%)	N/A	N/A	Clear Space?	N/A
	Road X Slope (%)	N/A	N/A	Clear Space to XWalk (in)	N/A
N/A	Any Obstructions?	N/A	N/A	Storm Grate/Utility Hazard?	N/A
	Obstruction Type			Storm Grate/Utility Type	
		N/A			N/A
			Yes	Surface Condition? (G/P)	Good

Remove & Replace Entire Ramp.
