# Access Compliance Report

## Public Rights-of-Way

| Intersection ID: 50320 | Main Street: BRYN_ATHYN_CT | Cross Street: CINDY_LN | Location: SE |
| ADA ID: A928C4F8C2E3 | Ramp Type: Directional1 | Initial Pass/Fail: Pass | Overall Compliance: No |

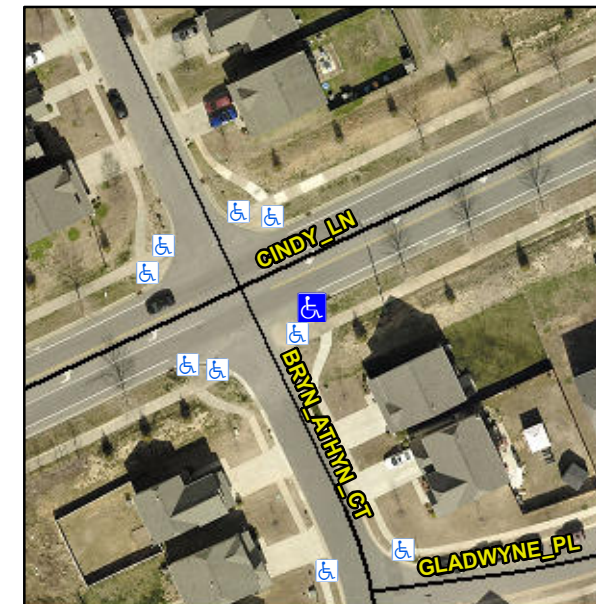
| Severity Score: 2.75 | | | |

| Compliance | Description | Data | Compliance | Description | Data |
|---|---|---|---|---|---|
| Yes | Ramp Slope (%) | 8.1 | No | Grade Break XSlope (%) | 4.9 |
| No | Landing Slope (%) | 2.4 | Yes | DWS Length (in) | 24.0 |
| No | Landing X Slope (%) | 5.0 | No | DWS Full Width? | No |
| N/A | Shared Landing? | Yes | No | DWS Offset RT (in) | 8.0 |
| Yes | Gutter Lip Ht (in) | 0.0 | No | Gutter X Slope (%) | 4.7 |

**Remove & Replace Entire Ramp.  
Remove & Replace Gutter.**

**R304.2.2-Perp, R304.3.2-Para,  
R304.5.3, R305.1.4, R305.2**
