Access Compliance Report

Public Rights-of-Way (Curb Ramps)

Intersection ID: 50651	Main Street: PINE_GLEN_CT	Cross Street: PINE_TERRACE_CT	Location:	N
ADA ID: A92F0AEAB759	Ramp Type: PerpDiag	Initial Pass/Fail: Fail	Overall Compliance: No	Severity Score: 25
Codes/Mitigation Info/Possible Solution		Field Measurements/Component Compliance

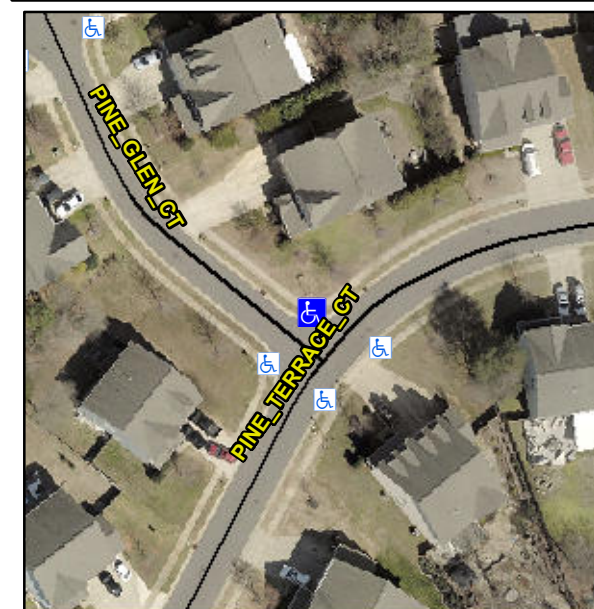
Compliance	Description	Data	Compliance	Description	Data
N/A	Ramp Length (in)	48.5	No	Ramp Slope (%)	8.4
Yes	Ramp Width (in)	48.0	No	Ramp XSlope (%)	5.1
N/A	Flare Type LT	N/A	N/A	Flare Type RT	N/A
N/A	Flare Slope LT (%)	N/A	N/A	Flare Slope RT (%)	N/A
N/A	Flare Traversable LT?	N/A	N/A	Flare Traversable RT?	N/A
N/A	Landing Length (in)	N/A	N/A	DWS Provided?	N/A
N/A	Landing Width (in)	N/A	N/A	DWS Contrast?	N/A
N/A	Landing Slope (%)	N/A	N/A	DWS Length (in)	N/A
N/A	Landing X Slope (%)	N/A	N/A	DWS Full Width?	N/A
N/A	Landing Curb? (Y/N)	N/A	N/A	DWS Offset (in)	N/A
N/A	Shared Landing?	N/A			
N/A	Gutter Ponding?	N/A	N/A	Gutter Slope (%)	N/A
N/A	Gutter Lip Ht (in)	N/A	N/A	Gutter X Slope (%)	N/A
N/A	Painted X Walk1?	No	N/A	Painted X Walk2?	No
	X Walk 1 Direction	To SW		X Walk 2 Direction	To SE
N/A	X Walk 1 Width (in)	N/A	N/A	X Walk 2 Width (in)	N/A
	X Walk 1 Slope (%)	3.1		X Walk 2 Slope (%)	0.9
	X Walk 1 X Slope (%)	1.7		X Walk 2 X Slope (%)	2.7

N/A	Ramp inside XWalk1?	N/A	N/A	Ramp inside XWalk2?	N/A
	Road Slope (%)	2.8	N/A	Clear Space?	N/A
	Road X Slope (%)	3.1	N/A	Clear Space to XWalk (in)	N/A
N/A	Any Obstructions?	N/A	N/A	Storm Grate/Utility Hazard?	N/A
	Obstruction Type			Storm Grate/Utility Type	
		N/A			N/A
			Yes	Surface Condition? (G/P)	Good

Possible Solutions:

Remove & Replace Curb Ramp With Two New Directional Ramps or Equivalent.

R304.2.2, R304.5.3
