Access Compliance Report

Public Rights-of-Way

(Curb Ramps)

Intersection ID: 12473	Main Street: S_CLARKSON_ST	Cross Street: W_PALMER_ST	Location: S
ADA ID: A939EC6BD488	Ramp Type: Directional2	Initial Pass/Fail: Fail	Overall Compliance: No
Codes/Mitigation Info/Possible Solution		Field Measurements/Component Compliance	
Severity Score: 8.75

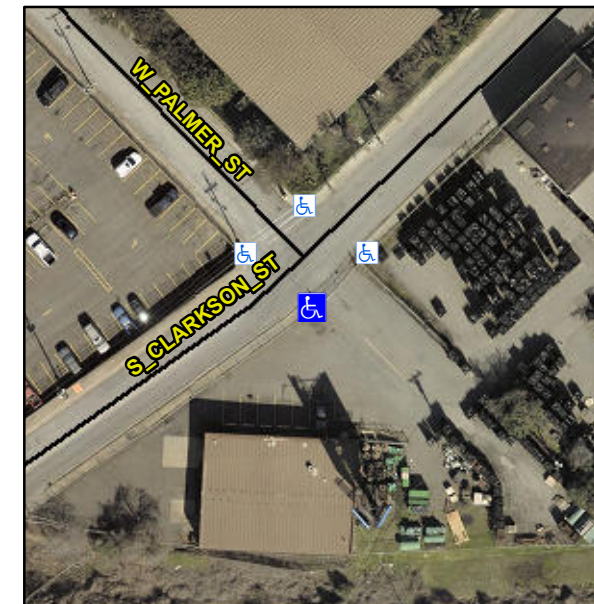
NO CURB

R304.5.1

Compliance	Description	Data	Compliance	Description	Data
N/A	Ramp Length (in)	53.0	N/A	Grade Break?	N/A
No	Ramp Width (in)	36.0	N/A	Grade Break Slope (%)	0.0
Yes	Ramp Slope (%)	5.1	N/A	Grade Break XSlope (%)	0.0
Yes	Ramp XSlope (%)	0.5			
N/A	Flare Type LT	N/A	N/A	Flare Type RT	N/A
N/A	Flare Slope LT (%)	N/A	N/A	Flare Slope RT (%)	0.0
N/A	Flare Traversable LT?	N/A	N/A	Flare Traversable RT?	N/A
N/A	Landing Length (in)	0.0	N/A	DWS Provided?	N/A
N/A	Landing Width (in)	0.0	N/A	DWS Contrast?	N/A
N/A	Landing Slope (%)	0.0	N/A	DWS Length (in)	N/A
N/A	Landing X Slope (%)	0.0	N/A	DWS Full Width?	N/A
N/A	Landing Curb? (Y/N)	N/A	N/A	DWS Offset LT (in)	N/A
N/A	Shared Landing?	N/A	N/A	DWS Offset RT (in)	N/A
N/A	Gutter Ponding?	0.0	N/A	Gutter Slope (%)	N/A
N/A	Gutter Lip Ht (in)	0.0	N/A	Gutter X Slope (%)	N/A
N/A	Painted X Walk1?	No		Road Slope (%)	3.5
	X Walk 1 Direction	To NE		Road X Slope (%)	0.3
	X Walk 1 Width (in)	N/A		Clear Space?	N/A

Remove & Replace Entire Ramp.
