Access Compliance Report Public Rights-of-Way (Curb Ramps)

Intersection ID: 2412 Main Street: HIDDEN_MEADOW_LN Cross Street: LAUREL_RUN_DR Location: N

ADA ID: A9515B9FC6C5 Ramp Type: PerpDiag Initial Pass/Fail: Fail Overall Compliance: No Severity Score: 8.75

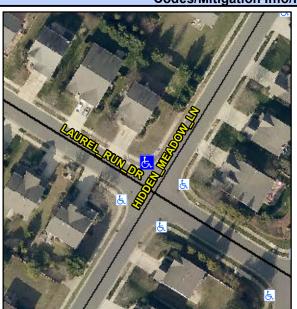
Not Found, R304.5.1

Compliance Description		Data	Compliance Description		Data
N/A	Ramp Length (in)	48.0	Yes	Ramp Slope (%)	7.0
No	Ramp Width (in)	46.0	Yes	Ramp XSlope (%)	0.3
N/A	Flare Type LT	N/A	N/A	Flare Type RT	N/A
N/A	Flare Slope LT (%)	N/A	N/A	Flare Slope RT (%)	N/A
N/A	Flare Traversable LT?	N/A	N/A	Flare Traversable RT?	N/A
N/A	Landing Length (in)	N/A	N/A	DWS Provided?	N/A
N/A	Landing Width (in)	N/A	N/A	DWS Contrast?	N/A
N/A	Landing Slope (%)	N/A	N/A	DWS Length (in)	N/A
N/A	Landing X Slope (%)	N/A	N/A	DWS Full Width?	N/A
N/A	Landing Curb? (Y/N)	N/A	N/A	DWS Offset (in)	N/A
N/A	Shared Landing?	N/A			
N/A	Gutter Ponding?	N/A	N/A	Gutter Slope (%)	N/A
N/A	Gutter Lip Ht (in)	N/A	N/A	Gutter X Slope (%)	N/A
N/A	Painted X Walk1?	No	N/A	Painted X Walk2?	No
	X Walk 1 Direction	To SW		X Walk 2 Direction	To SE
N/A	X Walk 1 Width (in)	N/A	N/A	X Walk 2 Width (in)	N/A
	X Walk 1 Slope (%)	3.9		X Walk 2 Slope (%)	2.0
	X Walk 1 X Slope (%)	3.1		X Walk 2 X Slope (%)	3.1

N/A	Ramp inside XWalk1?	N/A	N/A	Ramp inside XWalk2?	N/A
	Road Slope (%)	1.0	N/A	Clear Space?	N/A
	Road X Slope (%)	5.8	N/A	Clear Space to XWalk (in)	N/A
N/A	Any Obstructions?	N/A	N/A	Storm Grate/Utility Hazard?	N/A
	Obstruction Type		l	Storm Grate/Utility Type	
		N/A			N/A

Remove & Replace Curb Ramp With Two New Directional Ramps or Equivalent.
