Access Compliance Report

Public Rights-of-Way

(Curb Ramps)

Intersection ID: 44011	Main Street: AVONHURST_LN	Cross Street: BRADWELL_DR	Location: E
ADA ID: A97E680F41C1	Ramp Type: PerpDiag	Initial Pass/Fail: Fail	Overall Compliance: No
Severity Score: 46.25			
Codes/Mitigation Info/Possible Solution		Field Measurements/Component Compliance

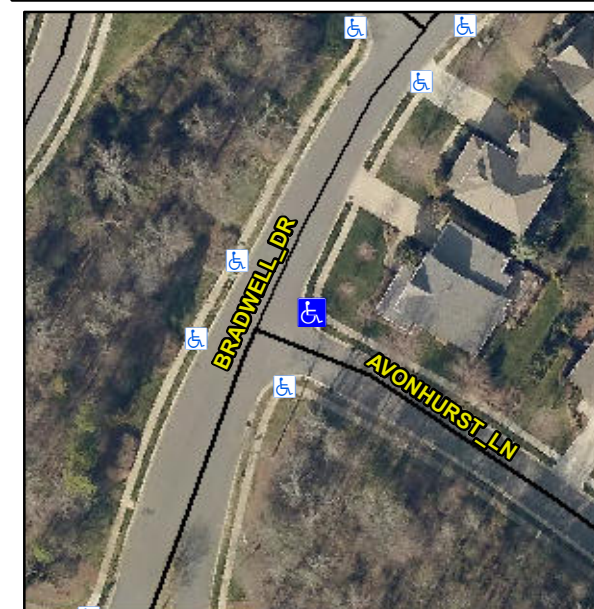
R304.5.1, R304.2.2, R304.5.3

Compliance	Description	Data	Compliance	Description	Data
N/A	Ramp Length (in)	47.5	No	Ramp Slope (%)	8.4
No	Ramp Width (in)	38.0	No	Ramp XSlope (%)	7.7
N/A	Flare Type LT	N/A	N/A	Flare Type RT	N/A
N/A	Flare Slope LT (%)	N/A	N/A	Flare Slope RT (%)	N/A
N/A	Flare Traversable LT?	N/A	N/A	Flare Traversable RT?	N/A
N/A	Landing Length (in)	N/A	N/A	DWS Provided?	N/A
N/A	Landing Width (in)	N/A	N/A	DWS Contrast?	N/A
N/A	Landing Slope (%)	N/A	N/A	DWS Length (in)	N/A
N/A	Landing X Slope (%)	N/A	N/A	DWS Full Width?	N/A
N/A	Landing Curb? (Y/N)	N/A	N/A	DWS Offset (in)	N/A
N/A	Shared Landing?	N/A			
N/A	Gutter Ponding?	N/A	N/A	Gutter Slope (%)	N/A
N/A	Gutter Lip Ht (in)	N/A	N/A	Gutter X Slope (%)	N/A
N/A	Painted X Walk1?	No	N/A	Painted X Walk2?	No
	X Walk 1 Direction	To NW		X Walk 2 Direction	To SW
N/A	X Walk 1 Width (in)	N/A	N/A	X Walk 2 Width (in)	N/A
	X Walk 1 Slope (%)	0.4		X Walk 2 Slope (%)	1.6
	X Walk 1 X Slope (%)	4.9		X Walk 2 X Slope (%)	3.5

N/A	Ramp inside XWalk1?	N/A	N/A	Ramp inside XWalk2?	N/A
	Road Slope (%)	4.6	N/A	Clear Space?	N/A
	Road X Slope (%)	0.1	N/A	Clear Space to XWalk (in)	N/A
N/A	Any Obstructions?	N/A	N/A	Storm Grate/Utility Hazard?	N/A
	Obstruction Type			Storm Grate/Utility Type	
		N/A			N/A
			Yes	Surface Condition? (G/P)	Good

Remove & Replace Curb Ramp With Two New Directional Ramps or Equivalent.
