Access Compliance Report

Public Rights-of-Way

(Curb Ramps)

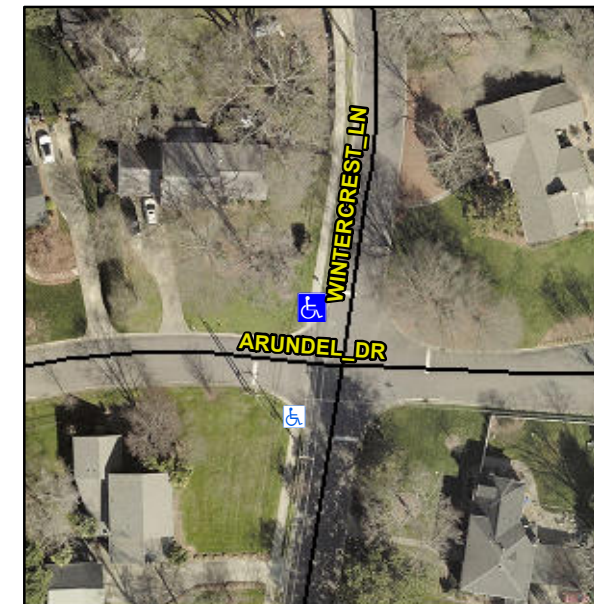
Intersection ID: 19731	Main Street: ARUNDEL_DR	Cross Street: WINTERCREST_LN	Location:	N
ADA ID: A98A7E162D47	Ramp Type: Directional1	Initial Pass/Fail: Fail	Overall Compliance: No	Severity Score: 12.5
Codes/Mitigation Info/Possible Solution		Field Measurements/Component Compliance

Compliance	Description	Data	Compliance	Description	Data
N/A	Ramp Length (in)	215.0	N/A	Grade Break?	N/A
Yes	Ramp Width (in)	61.0	N/A	Grade Break Slope (%)	0.0
Yes	Ramp Slope (%)	11.3	N/A	Grade Break XSlope (%)	0.0
Yes	Ramp XSlope (%)	0.5			
N/A	Flare Type LT	N/A	N/A	Flare Type RT	N/A
N/A	Flare Slope LT (%)	N/A	N/A	Flare Slope RT (%)	0.0
N/A	Flare Traversable LT?	N/A	N/A	Flare Traversable RT?	N/A
N/A	Landing Length (in)	0.0	N/A	DWS Provided?	N/A
N/A	Landing Width (in)	0.0	N/A	DWS Contrast?	N/A
N/A	Landing Slope (%)	0.0	N/A	DWS Length (in)	N/A
N/A	Landing X Slope (%)	0.0	N/A	DWS Full Width?	N/A
N/A	Landing Curb? (Y/N)	N/A	N/A	DWS Offset LT (in)	N/A
N/A	Shared Landing?	N/A	N/A	DWS Offset RT (in)	N/A
N/A	Gutter Ponding?	0.0	N/A	Gutter Slope (%)	N/A
N/A	Gutter Lip Ht (in)	0.0	N/A	Gutter X Slope (%)	N/A
N/A	Painted X Walk1?	No		Road Slope (%)	2.9
	X Walk 1 Direction	To S		Road X Slope (%)	8.6
	X Walk 1 Width (in)	N/A		Clear Space?	N/A

X Walk 1 Slope (%)	2.9	N/A	Clear Space to XWalk (in)	N/A
	X Walk 1 X Slope (%)	8.6	N/A	Storm Grate/Utility Hazard?	N/A
N/A	Ramp inside XWalk1?	N/A		Storm Grate/Utility Type	
N/A	Any Obstructions?	N/A			N/A
	Obstruction Type		Yes	Surface Condition? (G/P)	Good
			N/A	Curb Slope (%)	10.6

Possible Solutions:

Remove & Replace Entire Ramp.
