Access Compliance Report

Public Rights-of-Way

(Curb Ramps)

Intersection ID: 44479	Main Street: REDDING_GLEN_AV	Cross Street: DARWICK_ST	Location: SE
ADA ID: A98AC2F33267	Ramp Type: PerpDiag	Initial Pass/Fail: Fail	Overall Compliance: No
		Severity Score: 8.75

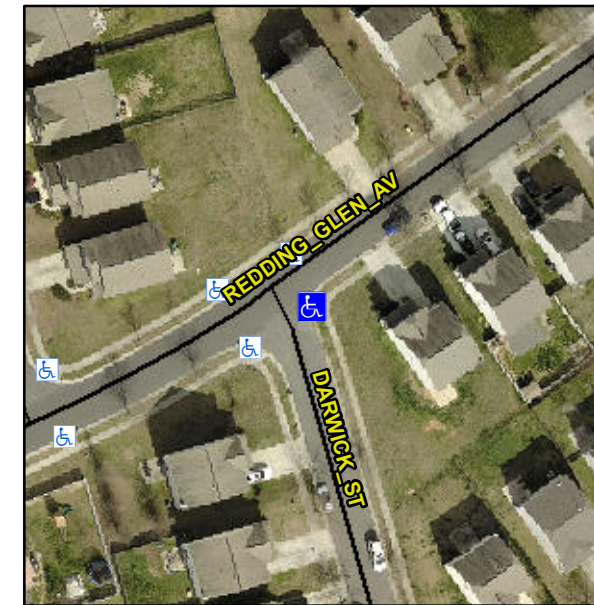
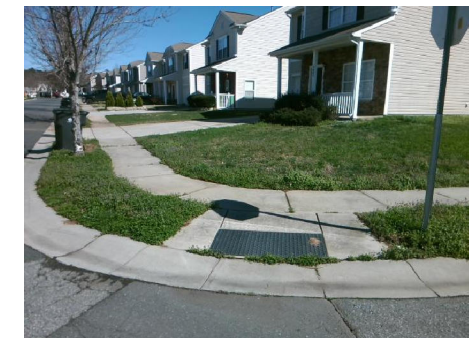
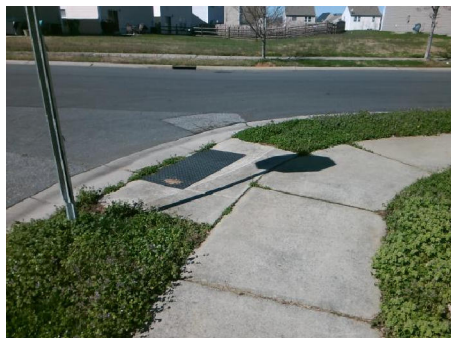
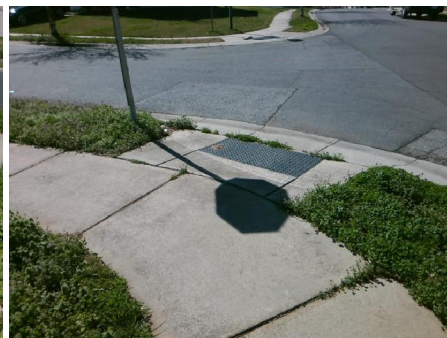
Not Found, R304.5.1

Compliance	Description	Data	Compliance	Description	Data
N/A	Ramp Length (in)	48.0	Yes	Ramp Slope (%)	5.9
No	Ramp Width (in)	46.0	Yes	Ramp XSlope (%)	0.1
N/A	Flare Type LT	N/A	N/A	Flare Type RT	N/A
N/A	Flare Slope LT (%)	N/A	N/A	Flare Slope RT (%)	N/A
N/A	Flare Traversable LT?	N/A	N/A	Flare Traversable RT?	N/A
N/A	Landing Length (in)	N/A	N/A	DWS Provided?	N/A
N/A	Landing Width (in)	N/A	N/A	DWS Contrast?	N/A
N/A	Landing Slope (%)	N/A	N/A	DWS Length (in)	N/A
N/A	Landing X Slope (%)	N/A	N/A	DWS Full Width?	N/A
N/A	Landing Curb? (Y/N)	N/A	N/A	DWS Offset (in)	N/A
N/A	Shared Landing?	N/A			
N/A	Gutter Ponding?	N/A	N/A	Gutter Slope (%)	N/A
N/A	Gutter Lip Ht (in)	N/A	N/A	Gutter X Slope (%)	N/A
N/A	Painted X Walk1?	No	N/A	Painted X Walk2?	No
	X Walk 1 Direction	To N		X Walk 2 Direction	To W
N/A	X Walk 1 Width (in)	N/A	N/A	X Walk 2 Width (in)	N/A
	X Walk 1 Slope (%)	3.5		X Walk 2 Slope (%)	1.7
	X Walk 1 X Slope (%)	0.5		X Walk 2 X Slope (%)	1.6

N/A	Ramp inside XWalk1?	N/A	N/A	Ramp inside XWalk2?	N/A
	Road Slope (%)	1.7	N/A	Clear Space?	N/A
	Road X Slope (%)	1.5	N/A	Clear Space to XWalk (in)	N/A
N/A	Any Obstructions?	N/A	N/A	Storm Grate/Utility Hazard?	N/A
	Obstruction Type			Storm Grate/Utility Type	
		N/A			N/A
			Yes	Surface Condition? (G/P)	Good

Remove & Replace Curb Ramp With Two New Directional Ramps or Equivalent.
