Access Compliance Report

Public Rights-of-Way

(Curb Ramps)

Intersection ID: 44307	Main Street: OLIVIA_DIANE_LN	Cross Street: KIEV_DR	Location: NW
ADA ID: A9949E997242	Ramp Type: PerpDiag	Initial Pass/Fail: Fail	Overall Compliance: No
Severity Score: 10			
Codes/Mitigation Info/Possible Solution		Field Measurements/Component Compliance

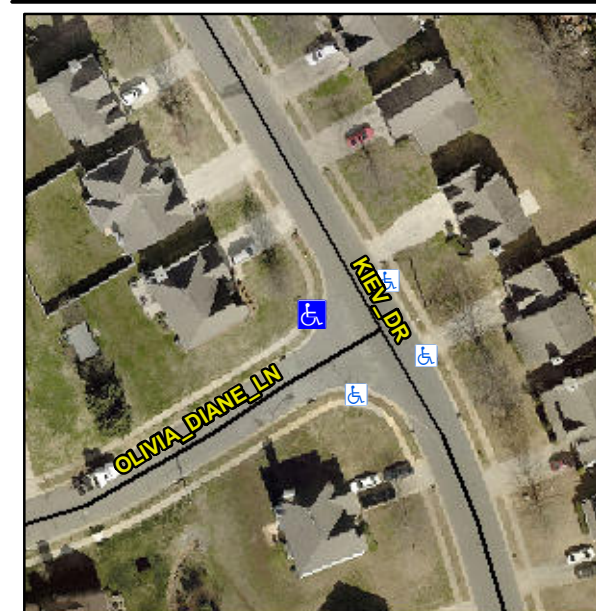
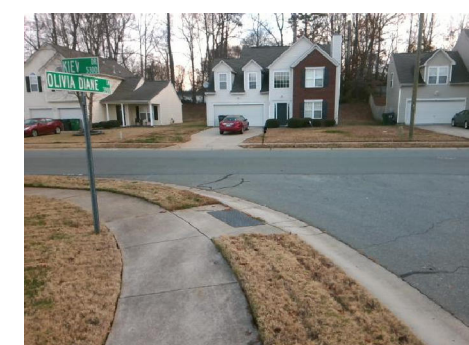
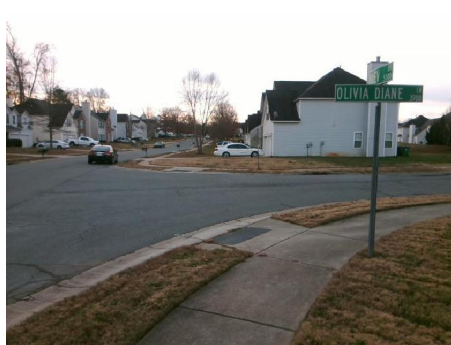
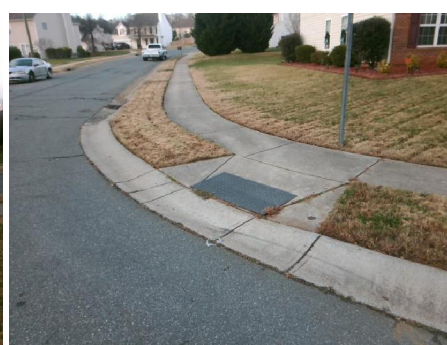
Not Found, R304.5.1, R304.5.3

Compliance	Description	Data	Compliance	Description	Data
N/A	Ramp Length (in)	48.5	Yes	Ramp Slope (%)	7.1
No	Ramp Width (in)	43.0	No	Ramp XSlope (%)	2.4
N/A	Flare Type LT	N/A	N/A	Flare Type RT	N/A
N/A	Flare Slope LT (%)	N/A	N/A	Flare Slope RT (%)	N/A
N/A	Flare Traversable LT?	N/A	N/A	Flare Traversable RT?	N/A
N/A	Landing Length (in)	N/A	N/A	DWS Provided?	N/A
N/A	Landing Width (in)	N/A	N/A	DWS Contrast?	N/A
N/A	Landing Slope (%)	N/A	N/A	DWS Length (in)	N/A
N/A	Landing X Slope (%)	N/A	N/A	DWS Full Width?	N/A
N/A	Landing Curb? (Y/N)	N/A	N/A	DWS Offset (in)	N/A
N/A	Shared Landing?	N/A			
N/A	Gutter Ponding?	N/A	N/A	Gutter Slope (%)	N/A
N/A	Gutter Lip Ht (in)	N/A	N/A	Gutter X Slope (%)	N/A
N/A	Painted X Walk1?	No	N/A	Painted X Walk2?	No
	X Walk 1 Direction	To S		X Walk 2 Direction	To E
N/A	X Walk 1 Width (in)	N/A	N/A	X Walk 2 Width (in)	N/A
	X Walk 1 Slope (%)	0.4		X Walk 2 Slope (%)	1.6
	X Walk 1 X Slope (%)	1.8		X Walk 2 X Slope (%)	1.4

N/A	Ramp inside XWalk1?	N/A	N/A	Ramp inside XWalk2?	N/A
	Road Slope (%)	2.2	N/A	Clear Space?	N/A
	Road X Slope (%)	1.6	N/A	Clear Space to XWalk (in)	N/A
N/A	Any Obstructions?	N/A	N/A	Storm Grate/Utility Hazard?	N/A
	Obstruction Type			Storm Grate/Utility Type	
		N/A			N/A
		Yes		Surface Condition? (G/P)	Good

Remove & Replace Curb Ramp With Two New Directional Ramps or Equivalent.
