# Access Compliance Report

## Public Rights-of-Way

### (Curb Ramps)

Intersection ID: 51502	Main Street: DEARVIEW_LN	Cross Street: EASTFIELD_PARK_DR	Location: N
ADA ID: A99A0A8BD49A	Ramp Type: PerpDiag	Initial Pass/Fail: Fail	Overall Compliance: No
Severity Score: 8.75			
Codes/Mitigation Info/Possible Solution		Field Measurements/Component Compliance

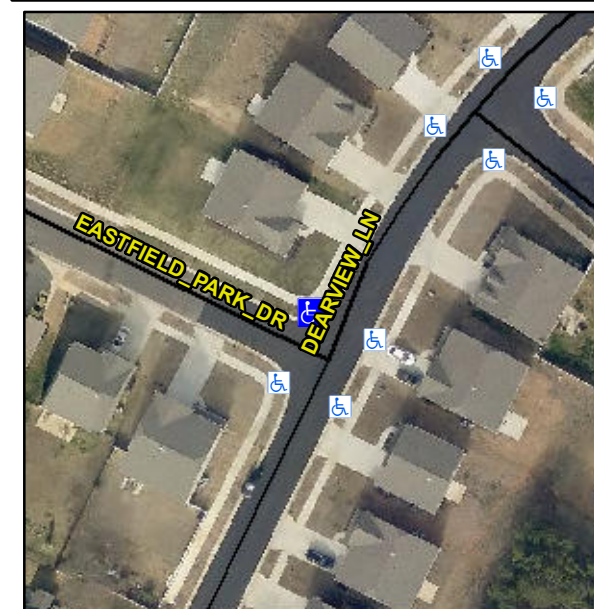
**Not Found, R304.5.1**

Compliance	Description	Data	Compliance	Description	Data
N/A	Ramp Length (in)	73.0	Yes	Ramp Slope (%)	5.1
No	Ramp Width (in)	47.0	Yes	Ramp XSlope (%)	0.9
N/A	Flare Type LT	N/A	N/A	Flare Type RT	N/A
N/A	Flare Slope LT (%)	N/A	N/A	Flare Slope RT (%)	N/A
N/A	Flare Traversable LT?	N/A	N/A	Flare Traversable RT?	N/A
N/A	Landing Length (in)	N/A	N/A	DWS Provided?	N/A
N/A	Landing Width (in)	N/A	N/A	DWS Contrast?	N/A
N/A	Landing Slope (%)	N/A	N/A	DWS Length (in)	N/A
N/A	Landing X Slope (%)	N/A	N/A	DWS Full Width?	N/A
N/A	Landing Curb? (Y/N)	N/A	N/A	DWS Offset (in)	N/A
N/A	Shared Landing?	N/A			
N/A	Gutter Ponding?	N/A	N/A	Gutter Slope (%)	N/A
N/A	Gutter Lip Ht (in)	N/A	N/A	Gutter X Slope (%)	N/A
N/A	Painted X Walk1?	No	N/A	Painted X Walk2?	No
	X Walk 1 Direction	To SW		X Walk 2 Direction	To SE
N/A	X Walk 1 Width (in)	N/A	N/A	X Walk 2 Width (in)	N/A
	X Walk 1 Slope (%)	3.1		X Walk 2 Slope (%)	2.3
	X Walk 1 X Slope (%)	2.5		X Walk 2 X Slope (%)	4.6

N/A	Ramp inside XWalk1?	N/A	N/A	Ramp inside XWalk2?	N/A
	Road Slope (%)	0.9	N/A	Clear Space?	N/A
	Road X Slope (%)	3.0	N/A	Clear Space to XWalk (in)	N/A
N/A	Any Obstructions?	N/A	N/A	Storm Grate/Utility Hazard?	N/A
	Obstruction Type			Storm Grate/Utility Type	
		N/A			N/A
			Yes	Surface Condition? (G/P)	Good

**Remove & Replace Curb Ramp With Two New Directional Ramps or Equivalent.**

Total Cost: \$ 3200.00
