# Access Compliance Report

## Public Rights-of-Way

### (Curb Ramps)

Intersection ID: 51618	Main Street: SUMMERFORD_DR	Cross Street: PROSPERITY_CHURCH_RD	Location: SE
ADA ID: A9A0543B0CFC	Ramp Type: PerpDiag	Initial Pass/Fail: Fail	Overall Compliance: No
Severity Score: 10			
Codes/Mitigation Info/Possible Solution		Field Measurements/Component Compliance

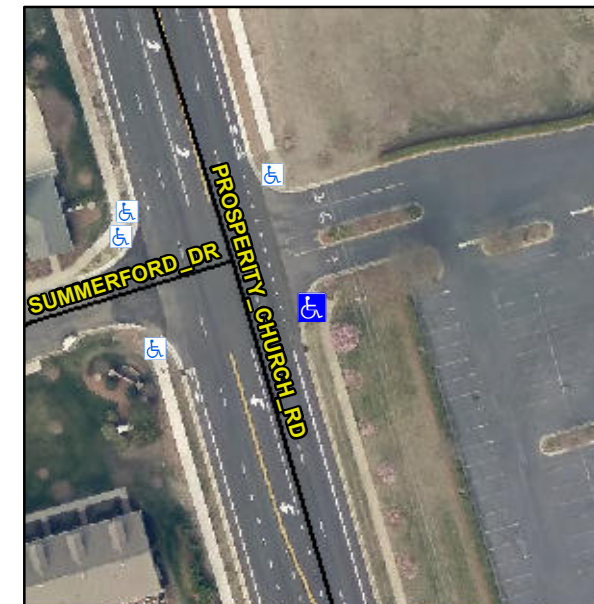
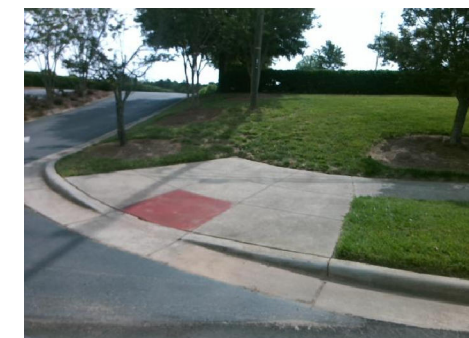
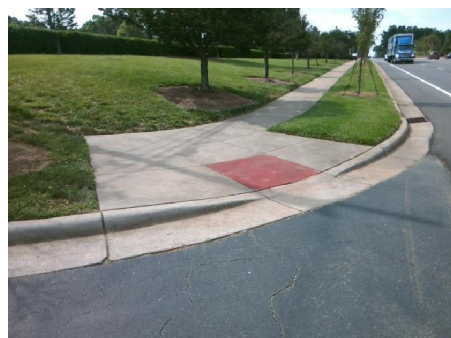
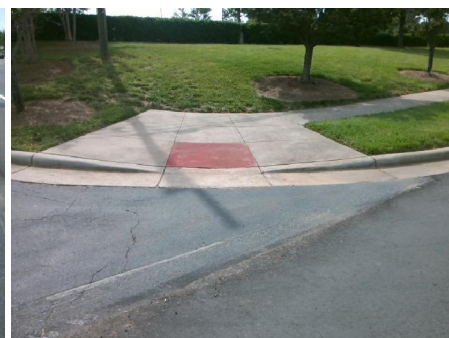
Compliance	Description	Data	Compliance	Description	Data
N/A	Ramp Length (in)	92.0	Yes	Ramp Slope (%)	8.3
No	Ramp Width (in)	45.5	No	Ramp XSlope (%)	3.0
N/A	Flare Type LT	N/A	N/A	Flare Type RT	N/A
N/A	Flare Slope LT (%)	N/A	N/A	Flare Slope RT (%)	N/A
N/A	Flare Traversable LT?	N/A	N/A	Flare Traversable RT?	N/A
N/A	Landing Length (in)	N/A	N/A	DWS Provided?	N/A
N/A	Landing Width (in)	N/A	N/A	DWS Contrast?	N/A
N/A	Landing Slope (%)	N/A	N/A	DWS Length (in)	N/A
N/A	Landing X Slope (%)	N/A	N/A	DWS Full Width?	N/A
N/A	Landing Curb? (Y/N)	N/A	N/A	DWS Offset (in)	N/A
N/A	Shared Landing?	N/A			
N/A	Gutter Ponding?	N/A	N/A	Gutter Slope (%)	N/A
N/A	Gutter Lip Ht (in)	N/A	N/A	Gutter X Slope (%)	N/A
N/A	Painted X Walk1?	No	N/A	Painted X Walk2?	No
	X Walk 1 Direction	To N		X Walk 2 Direction	To W
N/A	X Walk 1 Width (in)	N/A	N/A	X Walk 2 Width (in)	N/A
	X Walk 1 Slope (%)	1.1		X Walk 2 Slope (%)	1.8
	X Walk 1 X Slope (%)	5.8		X Walk 2 X Slope (%)	16.0

N/A	Ramp inside XWalk1?	N/A	N/A	Ramp inside XWalk2?	N/A
	Road Slope (%)	1.7	N/A	Clear Space?	N/A
	Road X Slope (%)	6.2	N/A	Clear Space to XWalk (in)	N/A
N/A	Any Obstructions?	N/A	N/A	Storm Grate/Utility Hazard?	N/A
	Obstruction Type			Storm Grate/Utility Type	
		N/A			N/A
			Yes	Surface Condition? (G/P)	Good

**Remove & Replace Curb Ramp With Two New Directional Ramps or Equivalent.**

**R304.5.1, R304.5.3**
