Access Compliance Report

Public Rights-of-Way

(Curb Ramps)

Intersection ID: 47099	Main Street: GALLERIA_BV	Cross Street: N/A	Location: NE
ADA ID: A9AA91C641CF	Ramp Type: Perp	Initial Pass/Fail: Fail	Overall Compliance: No
Codes/Mitigation Info/Possible Solution		Field Measurements/Component Compliance	
Severity Score: 22.5

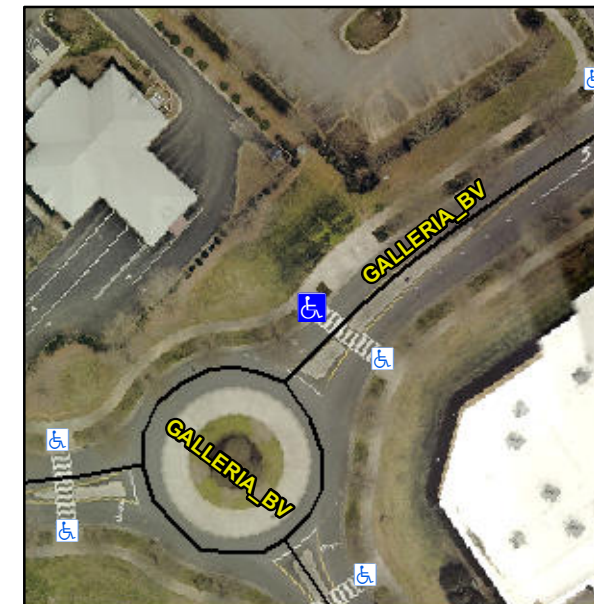
Not Found, R304.5.1, R304.2.2, R304.5.3

Compliance	Description	Data	Compliance	Description	Data
N/A	Ramp Length (in)	96.0	No	Ramp Slope (%)	9.1
No	Ramp Width (in)	41.0	No	Ramp XSlope (%)	2.2
N/A	Flare Type LT	N/A	N/A	Flare Type RT	N/A
N/A	Flare Slope LT (%)	N/A	N/A	Flare Slope RT (%)	N/A
N/A	Flare Traversable LT?	N/A	N/A	Flare Traversable RT?	N/A
N/A	Landing Length (in)	N/A	N/A	DWS Provided?	N/A
N/A	Landing Width (in)	N/A	N/A	DWS Contrast?	N/A
N/A	Landing Slope (%)	N/A	N/A	DWS Length (in)	N/A
N/A	Landing X Slope (%)	N/A	N/A	DWS Full Width?	N/A
N/A	Landing Curb? (Y/N)	N/A	N/A	DWS Offset (in)	N/A
N/A	Shared Landing?	N/A			
N/A	Gutter Ponding?	N/A	N/A	Gutter Slope (%)	N/A
N/A	Gutter Lip Ht (in)	N/A	N/A	Gutter X Slope (%)	N/A
N/A	Painted X Walk1?	Yes	N/A	Painted X Walk2?	N/A
	X Walk 1 Direction	To SE		X Walk 2 Direction	N/A
N/A	X Walk 1 Width (in)	111.0	N/A	X Walk 2 Width (in)	N/A
	X Walk 1 Slope (%)	2.2		X Walk 2 Slope (%)	N/A
	X Walk 1 X Slope (%)	0.7		X Walk 2 X Slope (%)	N/A

N/A	Ramp inside XWalk1?	Yes	N/A	Ramp inside XWalk2?	N/A
	Road Slope (%)	N/A	N/A	Clear Space?	N/A
	Road X Slope (%)	N/A	N/A	Clear Space to XWalk (in)	N/A
N/A	Any Obstructions?	N/A	N/A	Storm Grate/Utility Hazard?	N/A
	Obstruction Type			Storm Grate/Utility Type	
		N/A			N/A
		Yes		Surface Condition? (G/P)	Good

Possible Solutions:

Remove & Replace Entire Ramp.
