# Access Compliance Report

## Public Rights-of-Way

### (Curb Ramps)

Intersection ID: 10158	Main Street: MULBERRY_CHURCH_RD	Cross Street: TUCKASEEGEE_RD	Location: NE
ADA ID: A9C7BF9F102C	Ramp Type: Perp	Initial Pass/Fail: Fail	Overall Compliance: No
		Severity Score: 30

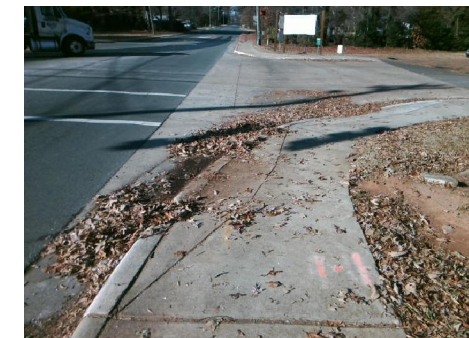
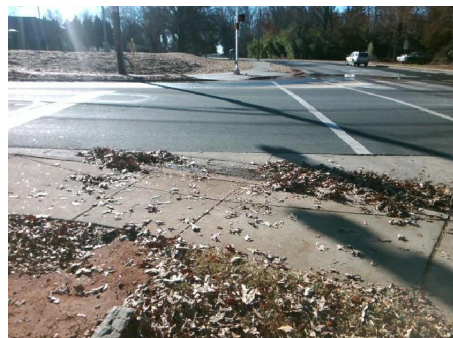
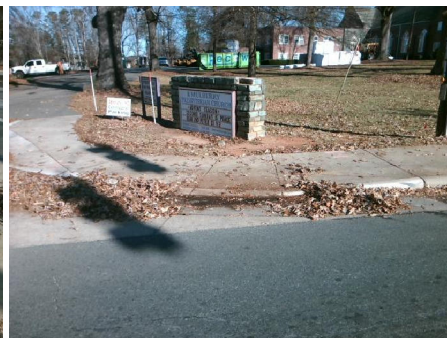
**Not Found, R304.5.1, R304.5.3**

Compliance	Description	Data	Compliance	Description	Data
N/A	Ramp Length (in)	60.0	Yes	Ramp Slope (%)	5.7
No	Ramp Width (in)	34.0	No	Ramp XSlope (%)	6.0
N/A	Flare Type LT	N/A	N/A	Flare Type RT	N/A
N/A	Flare Slope LT (%)	N/A	N/A	Flare Slope RT (%)	N/A
N/A	Flare Traversable LT?	N/A	N/A	Flare Traversable RT?	N/A
N/A	Landing Length (in)	N/A	N/A	DWS Provided?	N/A
N/A	Landing Width (in)	N/A	N/A	DWS Contrast?	N/A
N/A	Landing Slope (%)	N/A	N/A	DWS Length (in)	N/A
N/A	Landing X Slope (%)	N/A	N/A	DWS Full Width?	N/A
N/A	Landing Curb? (Y/N)	N/A	N/A	DWS Offset (in)	N/A
N/A	Shared Landing?	N/A			
N/A	Gutter Ponding?	N/A	N/A	Gutter Slope (%)	N/A
N/A	Gutter Lip Ht (in)	N/A	N/A	Gutter X Slope (%)	N/A
N/A	Painted X Walk1?	No	N/A	Painted X Walk2?	N/A
	X Walk 1 Direction	To S		X Walk 2 Direction	N/A
N/A	X Walk 1 Width (in)	N/A	N/A	X Walk 2 Width (in)	N/A
	X Walk 1 Slope (%)	5.1		X Walk 2 Slope (%)	N/A
	X Walk 1 X Slope (%)	1.1		X Walk 2 X Slope (%)	N/A

N/A	Ramp inside XWalk1?	N/A	N/A	Ramp inside XWalk2?	N/A
	Road Slope (%)	N/A	N/A	Clear Space?	N/A
	Road X Slope (%)	N/A	N/A	Clear Space to XWalk (in)	N/A
N/A	Any Obstructions?	N/A	N/A	Storm Grate/Utility Hazard?	N/A
	Obstruction Type			Storm Grate/Utility Type	
		N/A			N/A
			Yes	Surface Condition? (G/P)	Good

**Remove & Replace Entire Ramp.**

Total Cost: \$ 1850.00
